# Alaska Peninsula and Becharof National Wildlife Refuges

*Contaminant Assessment*

Alaska Peninsula and Becharof National Wildlife Refuges  
Contaminant Assessment

January 2004

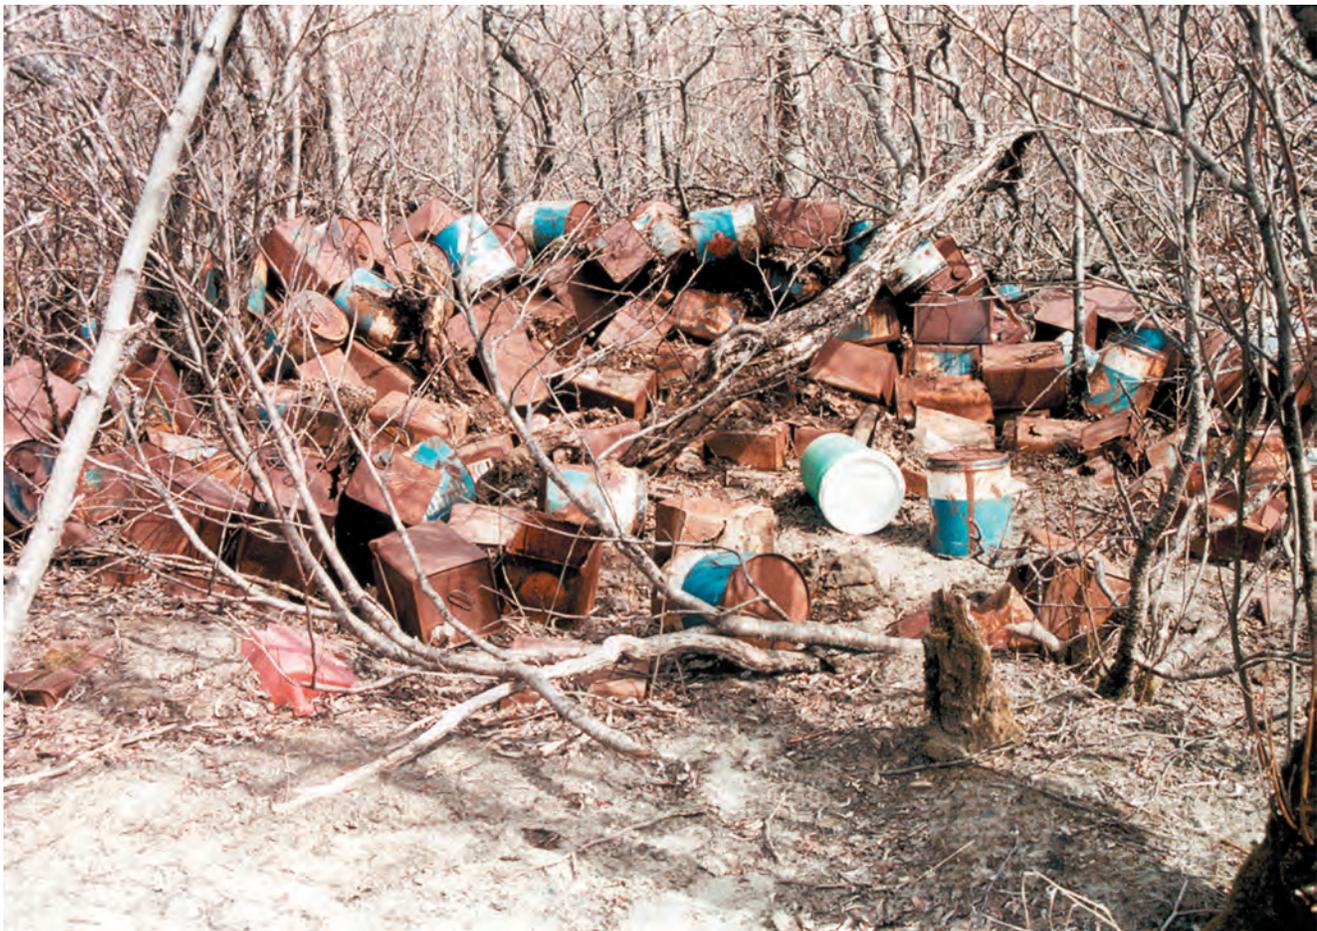
*Big game guide-outfitter camp on the Refuge prior to the “Take Pride in America” cleanup effort. Angela Terrell-Wagner/USFWS.*

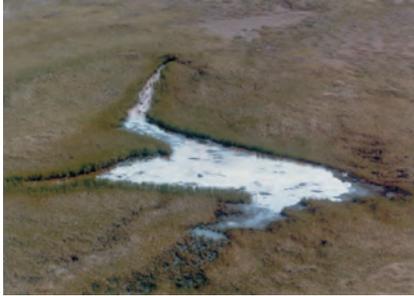
*Natural oil seeps like this attracted oil prospectors to the Alaska Peninsula.* Ronald E. Hood/USFWS.

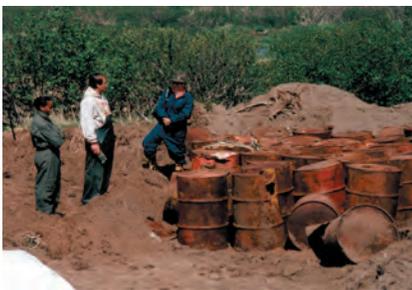
*Unearthed 55-gallon drums at Island Bay, 1992. Ronald E. Hood/USFWS.*

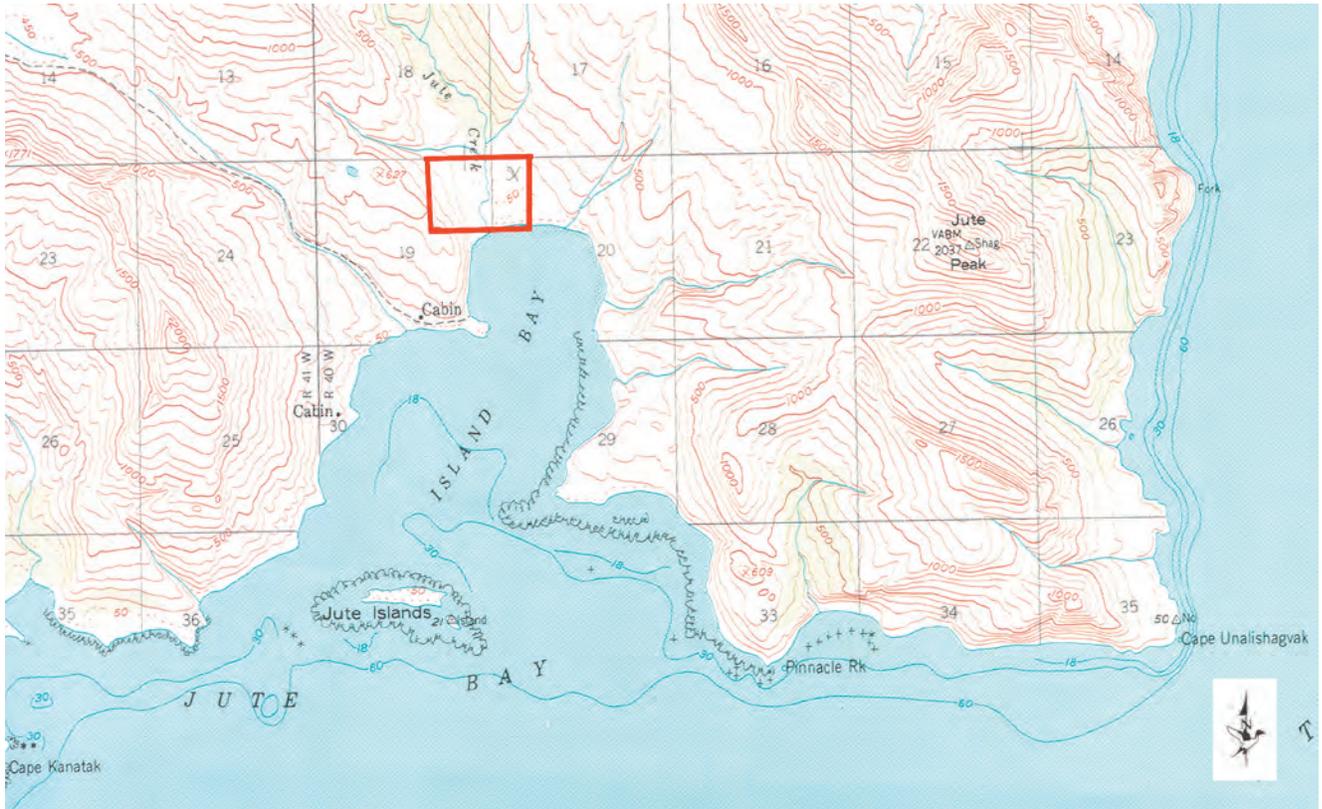
**Figure 5. Approximate Location of the Island Bay Drum Cache**

In 1988, during Jackson's contaminants investigation in locations where oil and gas exploration had occurred on the Refuge (see above), two caches of 55-gallon drums were discovered near the mouth of Jute Creek (Figure

5). The caches contained approximately 1,700 55-gallon drums; many were buried beneath the ground. A hydrocarbon sheen was apparent on the surface water in and around the area where the mostly empty drums were located. General Petroleum Corporation (a subsidiary of Mobil) built a dock and a road in the area to conduct oil exploration in the late 1950s, and Mobil agreed to remove the drum cache in June 1992. The cleanup was performed by Northern Exploration Services. During drum removal, Service personnel sampled soil and groundwater from and around the site to establish if residual contamination was an issue.

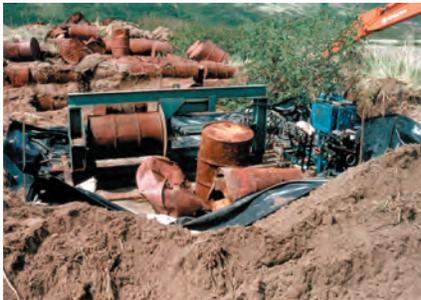
*Crushing the drums from the cache, 1992.* Ronald E. Hood/USFWS.

While the majority of the drums were empty, approximately 50 drums had minimal contents. When residues were found in the old rusty drums, they were transferred into new drums to prevent spillage. In June 1992 after the drum removal, Service personnel took 28 soil and 12 groundwater samples from 14 excavated pits where the drums had been stacked and in the general vicinity of the drum cache to determine if residual contamination could be detected. During a reconnaissance of this area prior to sample collection, a petroleum seep away from the cache area was discovered adjacent to the mouth of Jute Creek where it enters Island Bay. As a result of this discovery, three of the sampling pits were dug near the seep, and six soil samples and one water sample were collected. Two of these pits had a strong hydrocarbon smell, and the sand and gravel within the pits were gray and greasy up to six feet below the ground surface (bgs). All samples taken from the 14 pits were analyzed for aliphatic hydrocarbons, PAHs, and OCs; a complete listing of the analytes tested can be found in Appendix B.

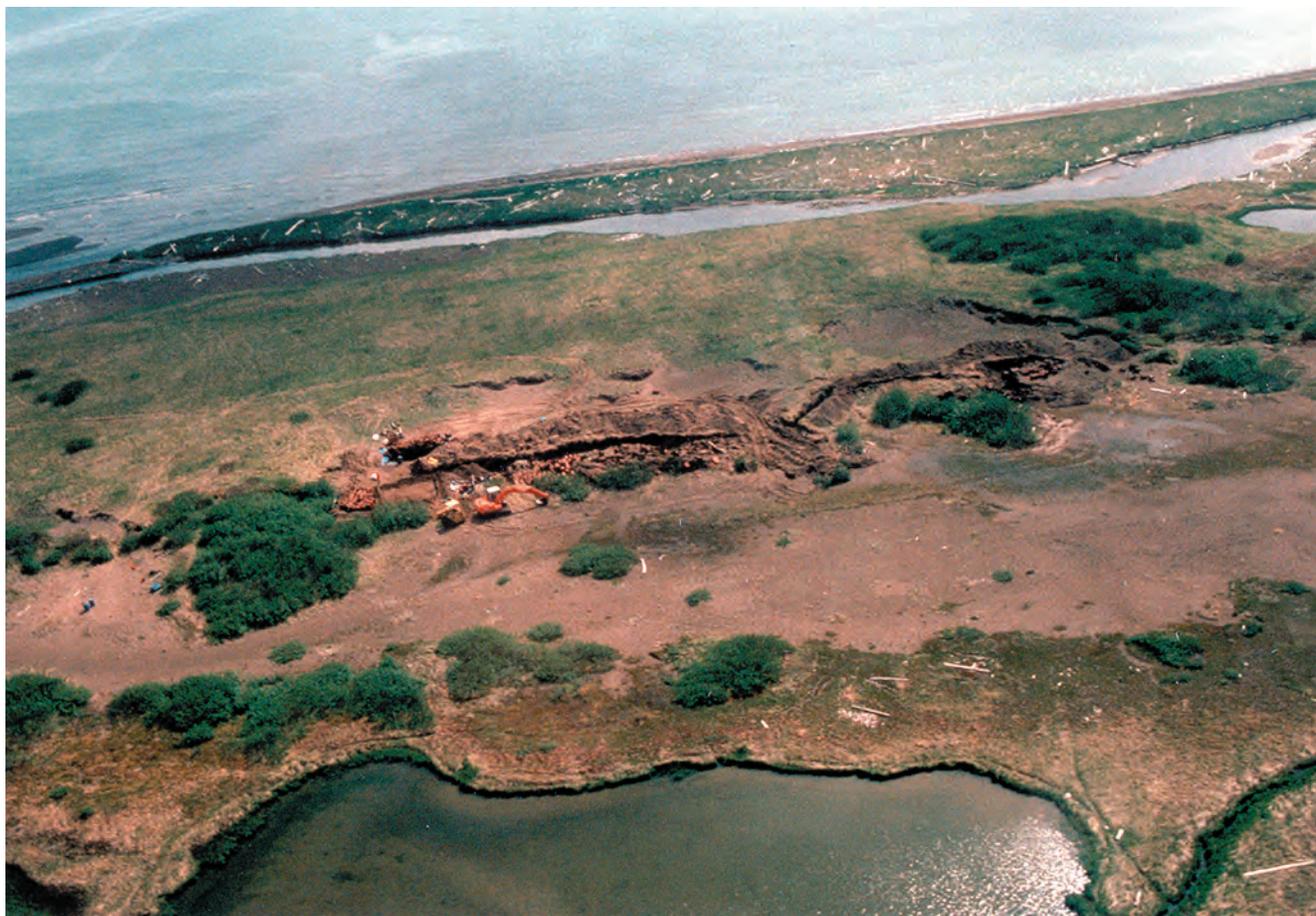
*Aerial view of the Island Bay drum cache and excavation.* Ronald E. Hood/USFWS.

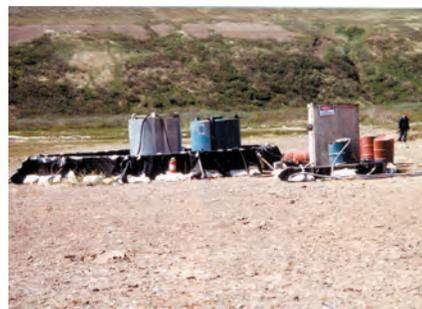
*Exxon's helicopter refueling site.*  
Ronald E. Hood/USFWS.

While investigating the petroleum seep on the banks of Jute Creek, it was discovered that this site was also a helicopter refueling site during the *Exxon Valdez* oil spill cleanup. Fuel contamination was detected at the site during decommissioning, so it is plausible that the high TPH concentrations (123 to 879 ppm dry wt) discovered at this location are attributable to spillage while the site was used as a refueling station. Although Exxon performed some soil excavation at this site in 1991 and concluded in January 1992 that the site required no further action, the detection of high TPH in June 1992 suggested that more hydrocarbon contamination may be present than previously discovered. The Exxon refueling site is discussed in greater detail below.

In January 1992, Exxon issued a letter to the ADEC and Service that recommended no further remediation or soil removal activities be conducted at the site. The Service issued a letter to Exxon dated February 1999 inquiring about further cleanup at this site. Currently, contaminant issues at this site remain unresolved.

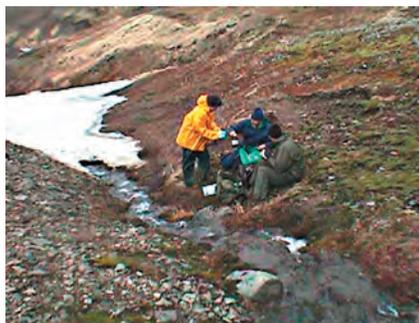
A reconnaissance of this site occurred on June 10, 1999, by Refuge, ADEC, and Exxon personnel. Shallow water (6 to 12 inches deep) covered about two-thirds of the reserve pit observed during previous site visits. Drilling wastes, such as lumber, plastic and metal debris, were exposed in several areas within the pit and sediment along the east edge of the pit created a sheen and odor when disturbed. It appeared that the reserve pit had been backfilled and graded, but a depression had formed due to the settling of the backfilled material, exposing the drilling wastes. The debris seen eroding into the stream during the 1988 and 1993 site visits could not be located. Four surface water samples were collected from the reserve pit (two samples total, one for quality control), down gradient from a channel at the east edge of the pad, and a background sample from a drainage creek north of the pad. Samples were analyzed for diesel range organics (DRO), benzene, toluene, ethylbenzene and xylene (BTEX), carcinogenic polynuclear aromatic hydrocarbons (cPAHs), and inorganics (As, Ba, Ca, Cr, Pb, Mg, Ni, Na, and Zn). DRO, BTEX, and cPAHs were not detected at or above the method detection limits. However, two samples collected at the reserve pit exceeded the Alaska Water Quality Standard (AWQS) for lead. The AWQS for lead is based on water hardness, and the standard for this site was calculated to be 0.54 parts per billion (ppb). The lead concentrations of the samples were 1.58 and 1.61 ppb. All other metal concentrations were below the AWQS.

*Reconnaissance to Bear Creek Well Number 1 in June 1999. USFWS.*

The closure plan by Exxon's consultant, Harding Lawson Associates, *Closure Plan Exxon Inactive Reserve Pit Bear Creek Unit 1 Near King Salmon, Alaska (January 2000)*, proposed further site characterization with additional sampling (a risk assessment may be necessary) and removal of solid waste from the site. The plan also stated that further

corrective action may be necessary depending on the risk assessment results. Exxon’s consultant, ENSR, conducted a risk assessment in 2001 evaluating the lead concentrations and hydrocarbon sheening at the site and determined they did not pose a risk to wildlife. The ADEC and Service have approved the closure plan for this site, but the Service reserved the right to have Exxon re-initiate cleanup activities if site conditions change.

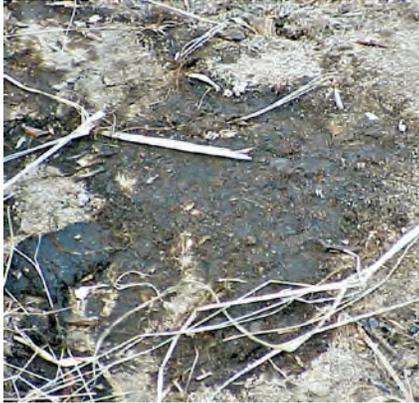
*Spill area at Lower Ugashik Lake cabin (approximately 2 feet by 2 feet).* Gary Melvin/USFWS.

During the August 2000 visit (Appendix C), a small petroleum spill was observed at the watchtower, accompanied by a strong hydrocarbon smell. A pronounced hydrocarbon smell was also noted at the generator shed, indicating the possible presence of spilled petroleum products. Most of the structures are located away from the lake, but the generator shed is within a few feet from the Lower Ugashik Lake shoreline. Numerous drums were scattered throughout the property, but it was unknown if any had contents. A workshop/parts room contained various materials, including paint, engine oil, etc., that need to be removed and disposed of properly. The fuel and storage areas, as well as the main cabin, may also contain items requiring proper disposal. The buildings had never been evaluated for lead paint or asbestos containing materials (ACM). Extensive vegetation and limited time precluded a more comprehensive investigation.

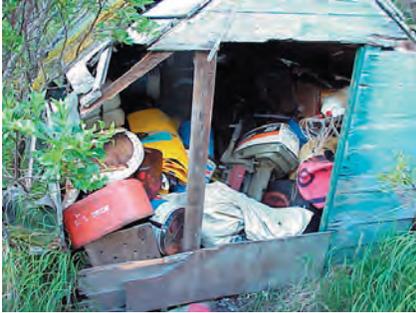
*Fuel shed at Lower Ugashik Lake cabin.* Gary Melvin/USFWS.

**Hydrocarbons:** No hydrocarbon releases were found at the site, although several sources for potential releases were investigated. There were 20+ 55-gallon drums scattered around the cabin area. Some drums contained up to 90% liquid, including 55 gallons of leaded fuel and 250 gallons of old watery fuel mixed with oil. Other liquids tested were determined to be gasoline, heating fuel, and camp stove oil. There were 57 discarded 5-gallon gas cans and nine discarded 5-gallon cans of Blazo fuel scattered throughout the various structures and on the property. Many of these had been placed inside the generator shed. Also, the fittings to the oil heaters that heat the cabin were determined to be possible sources of hydrocarbon contamination. Eleven soil samples were screened for hydrocarbons including GRO, DRO, RRO, and BTEX. DRO was detected in two samples, RRO was detected in every sample, and xylenes were detected in one sample. However, all soil hydrocarbons concentrations were below ADEC cleanup levels.

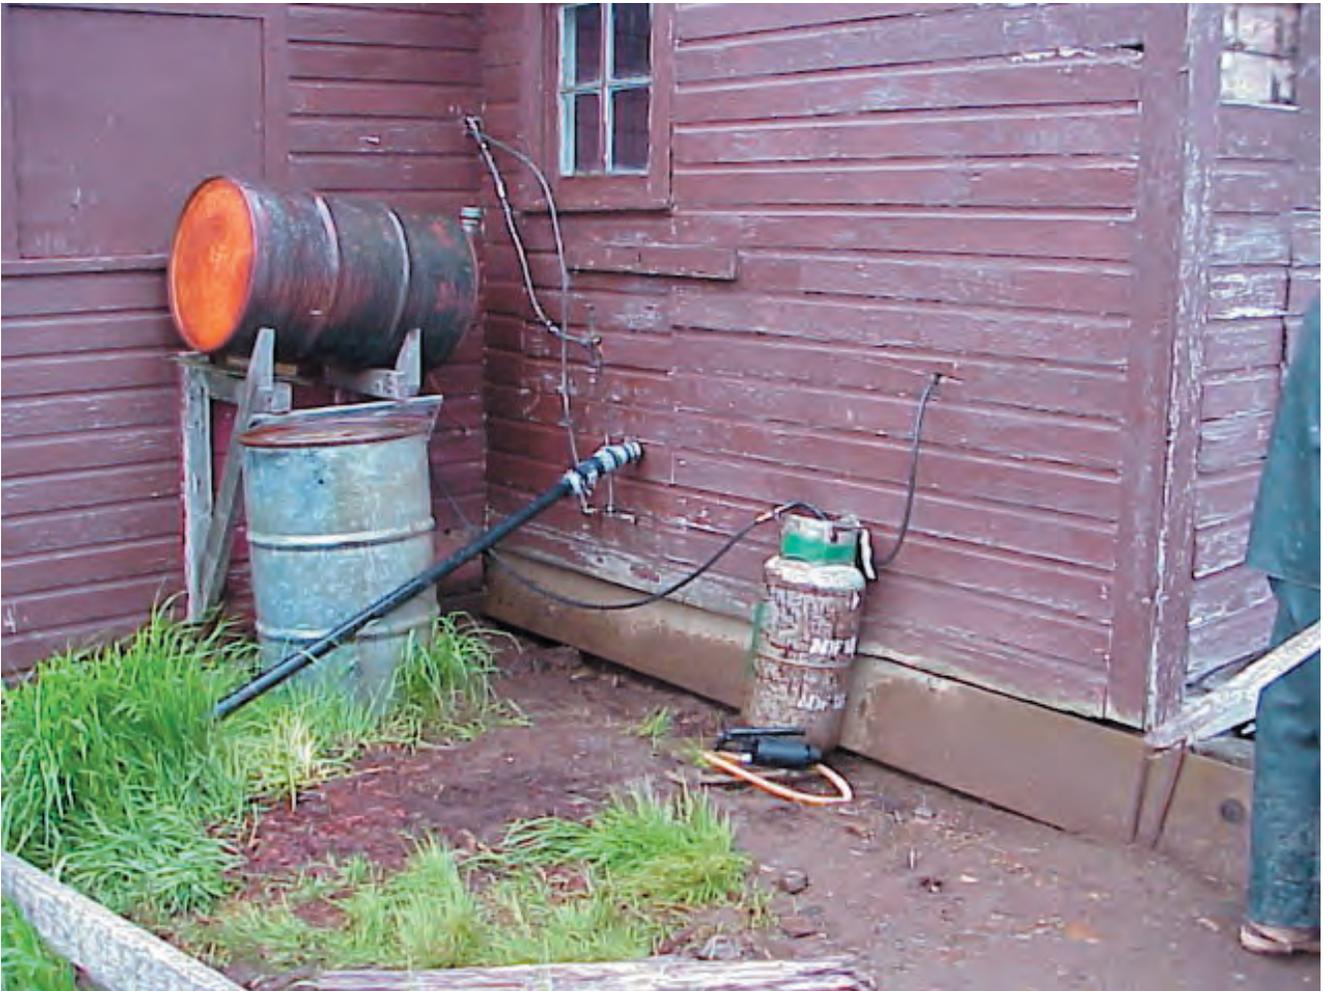
*Location of fuel spill at Egegik River Fisheries cabin.* Gary Melvin/USFWS.

*Hydrocarbons:* It is unclear whether ADF&G still uses fuel oil heating at this site. During the Environmental Phase II EDDA in summer 2002, Platt Environmental noted that the cabin was heated with heating fuel, contained in a 55-gallon heating fuel drum. Although a release was previously documented at this site, Platt's field screening and analytical results, further confirmed this release. Four soil samples were collected three feet bgs at the fuel release next to the cabin and analyzed for GRO, DRO, RRO, and BTEX. All of the soil samples had detectable levels of DRO and RRO, and three samples exceeded the ADEC cleanup level of 100 ppm for DRO at 285, 1,310, and 1,930 ppm. Approximately 200 cubic yards of soil have been contaminated by the spill.

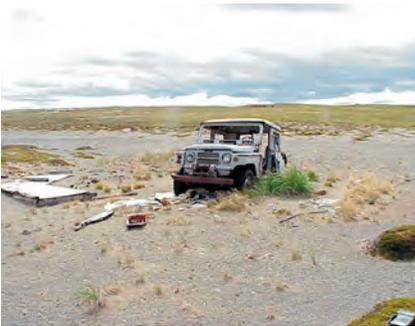
*Abandoned vehicle near the Trade and Manufacturing Site.* Gary Melvin/USFWS.

*Hydrocarbons and Vehicles:* The remains of a vehicle can be found approximately 30 yards upriver from the site. The vehicle’s oil pan appears to be intact and likely contains oil. A battery is located inside the vehicle. An abandoned three-wheeler with gasoline in its tank is located between the T&M site and the subsistence cabin. One soil sample was collected 6 inches bgs under the vehicle to test for hydrocarbons, including GRO, DRO, RRO, and BTEX. Only RRO (38.8 mg/kg) was detected in this sample and was far below the ADEC RRO cleanup level of 2,000 mg/kg.

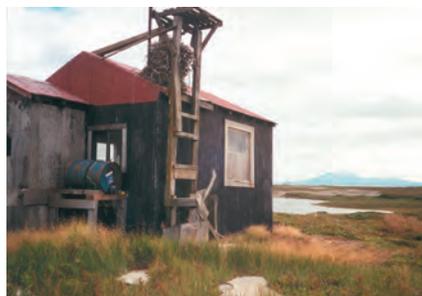
*Subsistence cabin along the banks of the Egegik River.* Tiffany Parson/USFWS.

In the 1990s, the Refuge apparently cleaned up a large number of old fuel cans and drums at this site. Refuge and EC staff visited this site in August 2000 during investigations associated with the CAP (Appendix C). A few scattered drums and 5-gallon fuel cans were located at the cabin along with miscellaneous debris, including an old snow machine. Contents (if any) of these drums and cans were unknown. As a result of the CAP, a proposal for further site evaluation was submitted and funded as part of the 2002 fiscal year Service Refuge Cleanup Project proposal process.

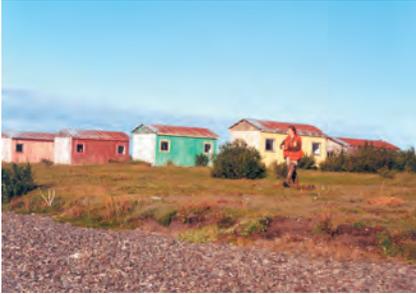
*Bible Camp.* Philip Johnson/USFWS.

*Hydrocarbons:* Surface staining was noted in several areas including near the mess hall, behind the bunkhouse, and around the steam bath. There are more than 20 55-gallon drums scattered at the site, containing various amounts of fuel. Numerous fuel cans were found in and around the structures including Coleman fuel, kerosene, Avgas, and Blazo containers. The contents of these containers total approximately 250 gallons of watery heating fuel and Avgas. A heating fuel release from the 55-gallon drum used to store heating fuel adjacent to the large bunk house has resulted in approximately 200 cubic yards of hydrocarbon contaminated soil. Six soil samples were analyzed for hydrocarbons, including GRO, DRO, RRO, and BTEX. One sample collected from the soil beneath the fuel drum at the mess hall exceeded the ADEC cleanup level for DRO (Table 7). Three soil samples around the drum cradle at the bunkhouse exceeded ADEC levels for GRO and/or DRO, and one sample approached the ADEC cleanup level for xylenes (Table 7).

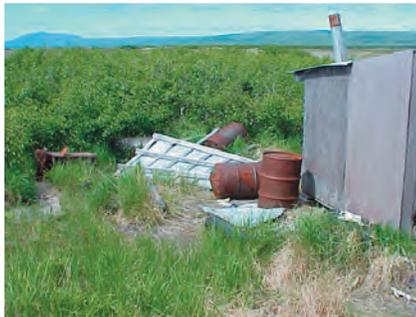
*Debris and drums at Bible Camp.*

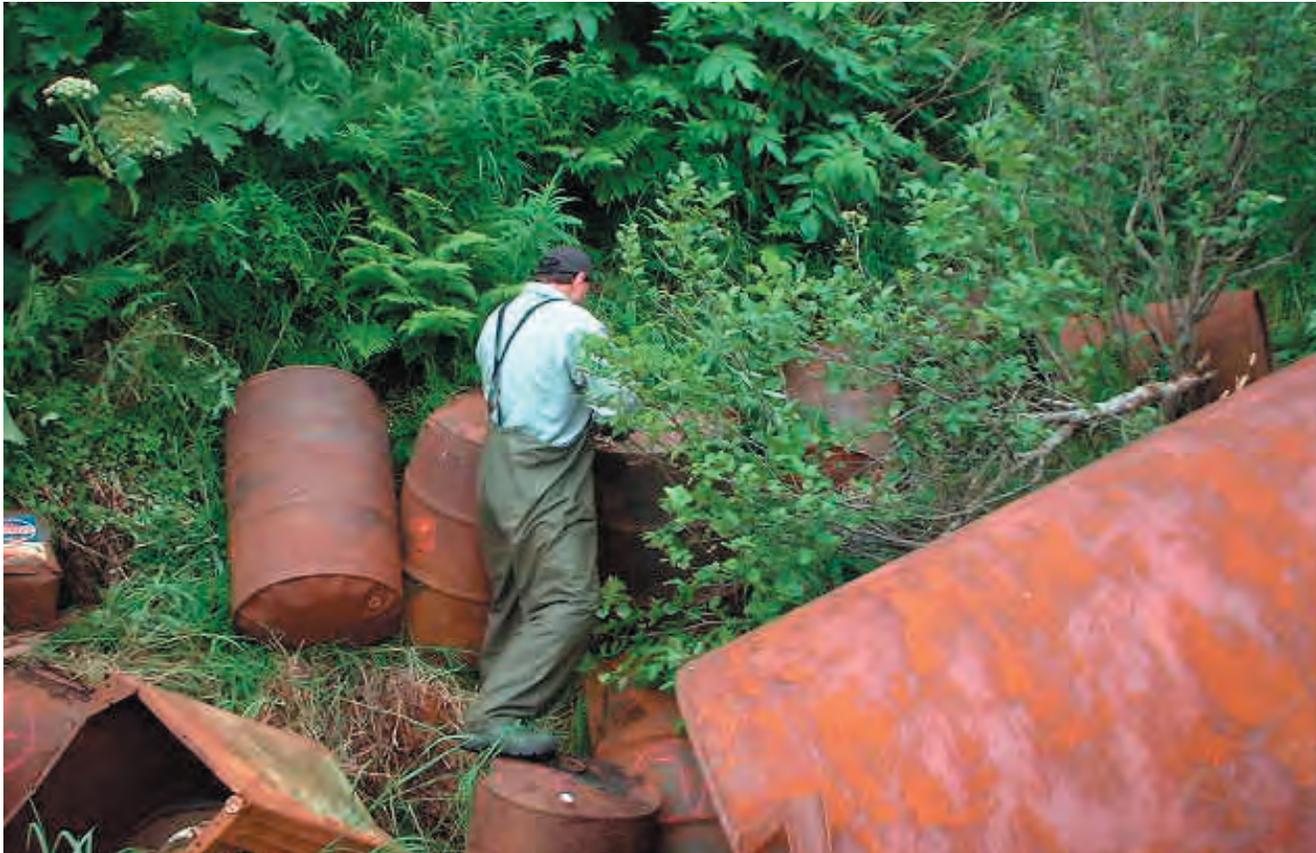
*Lead-Based Paint*: Two paint samples were analyzed for lead, one from paint on the wood debris of the former living quarters and one from paint on the wall of the core sample shed. Both samples exceeded the ADEC presence/absence standard for lead, with lead concentrations of 410 mg/kg

*Braided Creek mining site, 2002.* Platt Environmental.

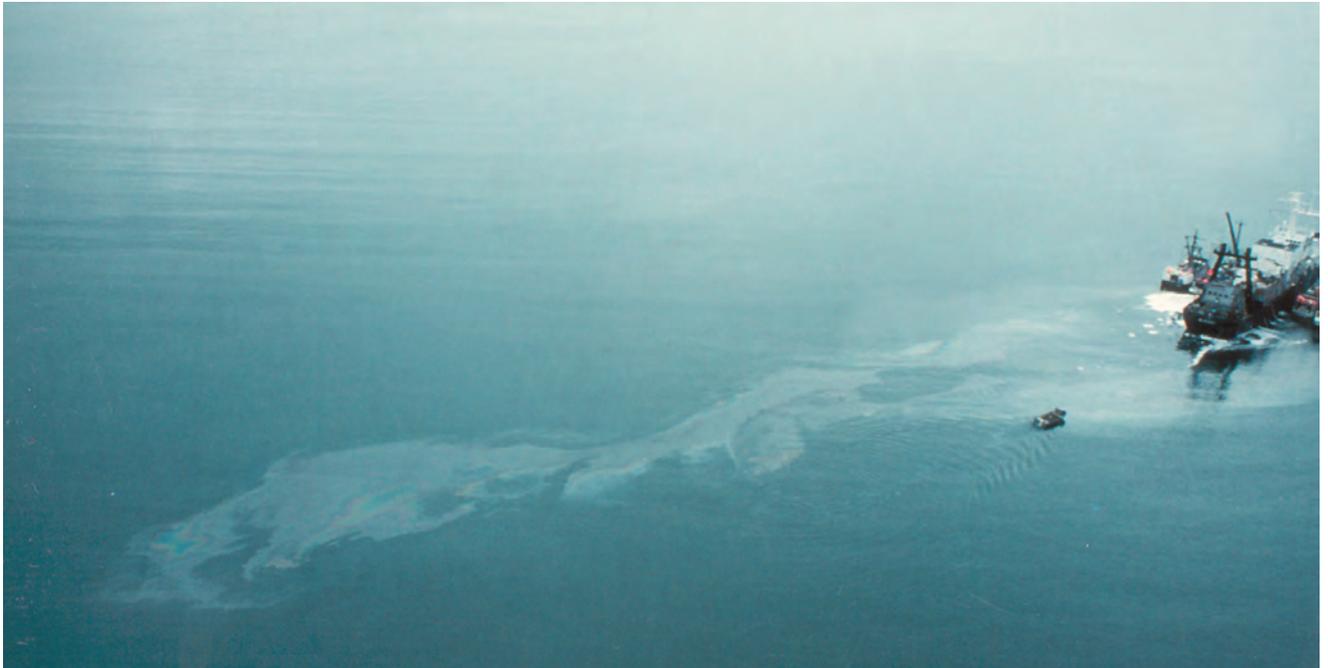
*While conducting shoreline reconnaissance in 1990 associated with the Exxon Valdez oil spill, a Refuge survey crew discovered this diesel spill from a fish processor in Ivanof Bay. Donna Dewhurst/USFWS.*

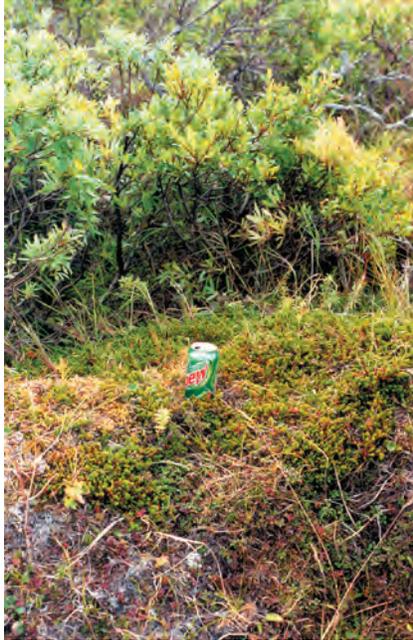
*A soda can left behind.* Tiffany Parson/  
USFWS.

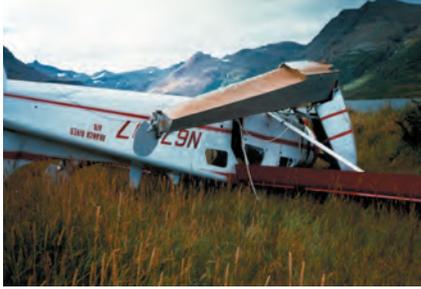
*Airplane crash in 1988.* John Payne/  
USFWS.

Numerous aircraft accidents have occurred over the years on the Refuge. It appears that most of the aircraft have been removed from the Refuge. These crashed aircraft likely pose more of a solid waste issue than a contaminant issue to Refuge lands, however, spilled aircraft fuel and lead from unrecovered batteries could be a minor issue. Additionally, fuel caches may pose a potential contaminant issue.

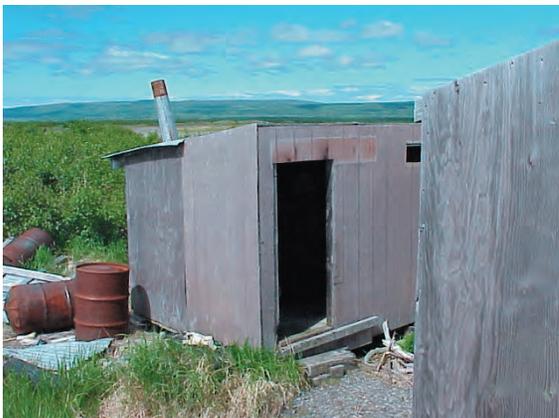
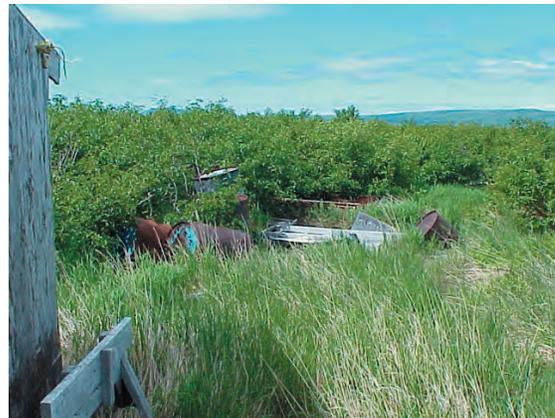
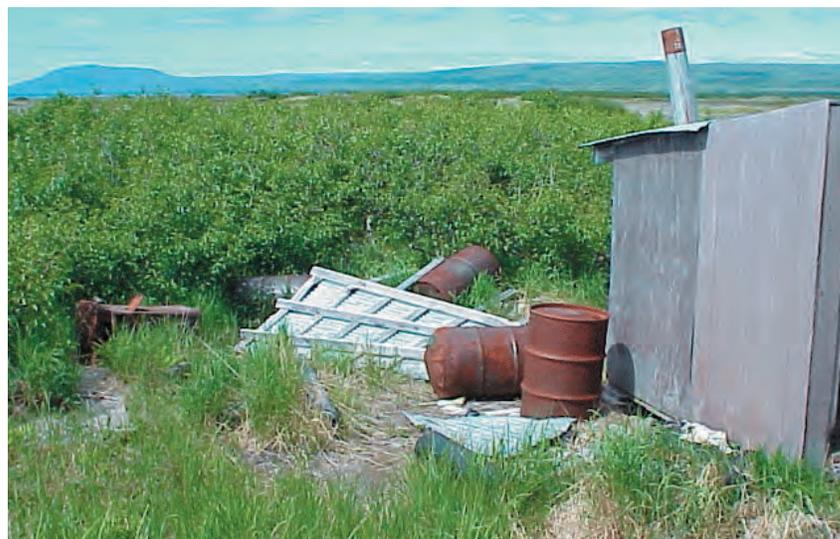
### 1. Bible Camp on Becharof Lake (N 57°55.18.09 W 156°04.47.26)

At least 40 buried/partially buried drums, generators, and other miscellaneous debris exist at this site. Much of the debris is covered by thick vegetation, so it is hard to determine the extent of the debris. It is impossible to see most of the debris from the air due to the dense vegetation. Contamination may result from leaking drums (if they have contents). It is recommended that all debris be removed as soon as possible. This site is used by the public for recreational and educational purposes.

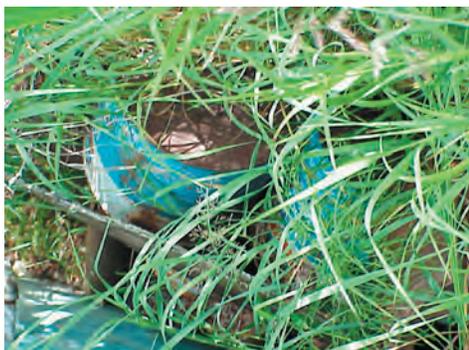
Five gallon fuel cans near the generator building.

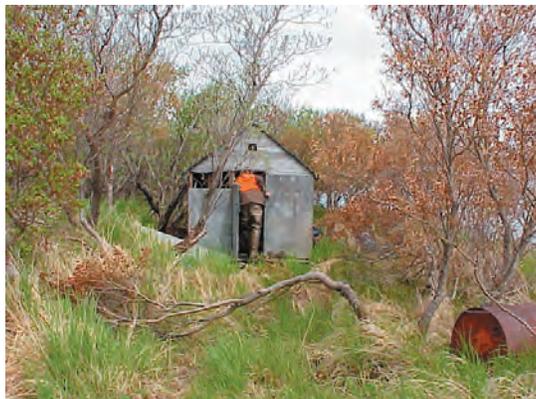
This site has a variety of potentially contaminated areas and solid waste issues. Other debris, parts, drums, etc. also are associated with this site. A generator building exists within 25 yards of the shore of Lower Ugashik Lake. The smell of hydrocarbons is very strong in and near the building. Fuel cans partially covered by dense vegetation can be found near the building.

Generator building.

There is a watch tower located at the site. A strong hydrocarbon smell associated with gear oil permeates the area surrounding the watch tower. Hydrocarbon contamination is obvious at this site, and some remediation may be necessary. It is recommended that all debris be removed from this site and that remediation occurs (if needed) as soon as possible.

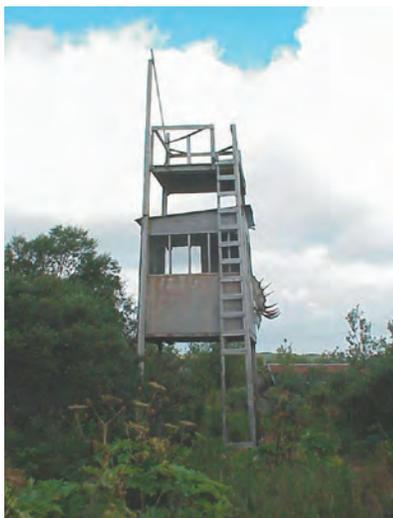
Watch tower.

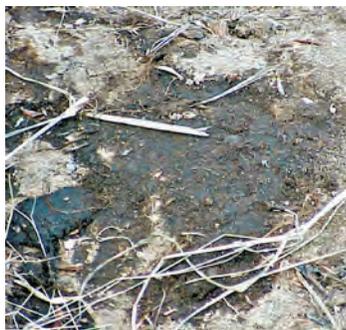
Hydrocarbon spill.

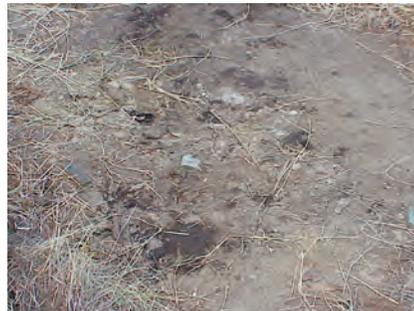
Hydrocarbon spill.

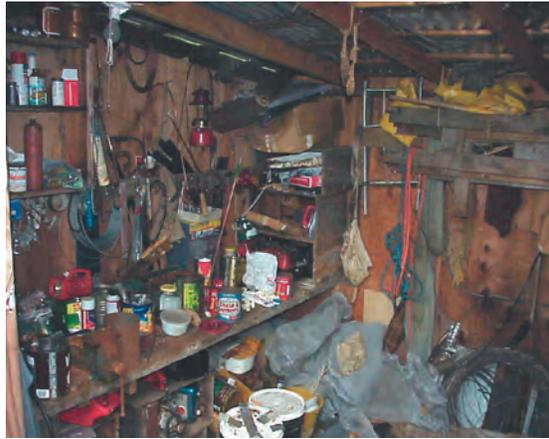
Parts room.

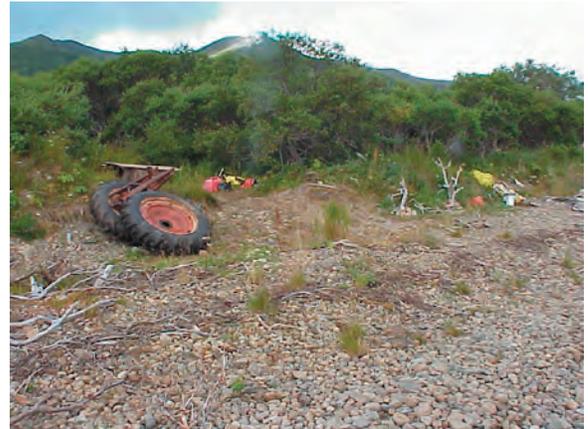
Miscellaneous debris.

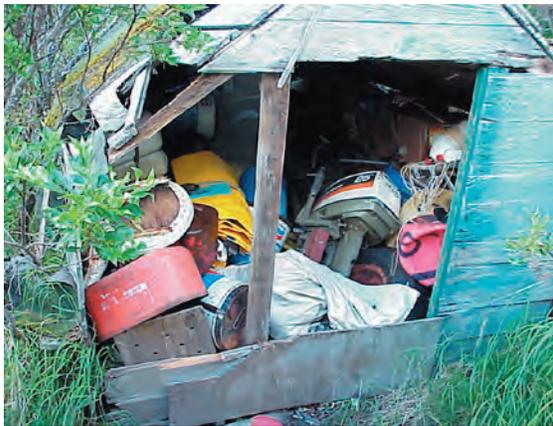
Fuel shed.

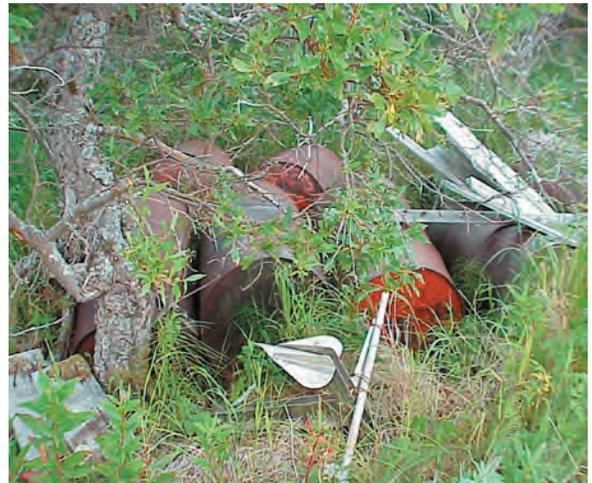
Drums by Ugashik Lake.

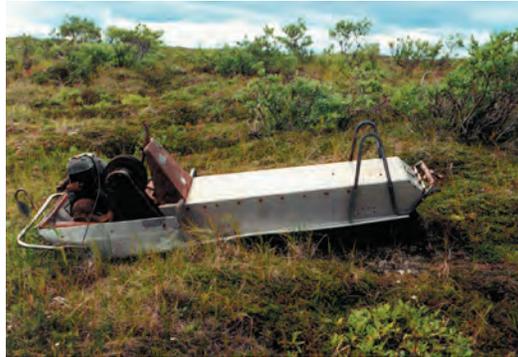
Some debris can be found in this area, such as a few 55-gallon and 5-gallon drums and an old snowmobile. It is recommended that all debris be removed from the area as soon as possible.

Old snowmobile.

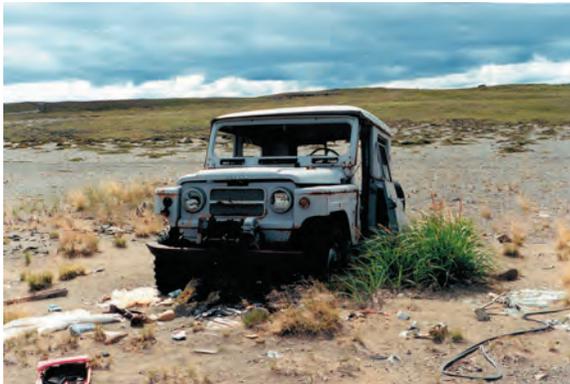
This area has debris ranging from an old jeep to batteries to empty Coleman fuel canisters. It is recommended that all debris be removed from the area as soon as possible.

Old jeep.

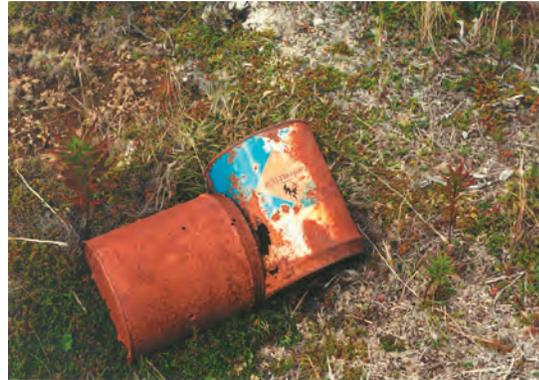
Five gallon cans.

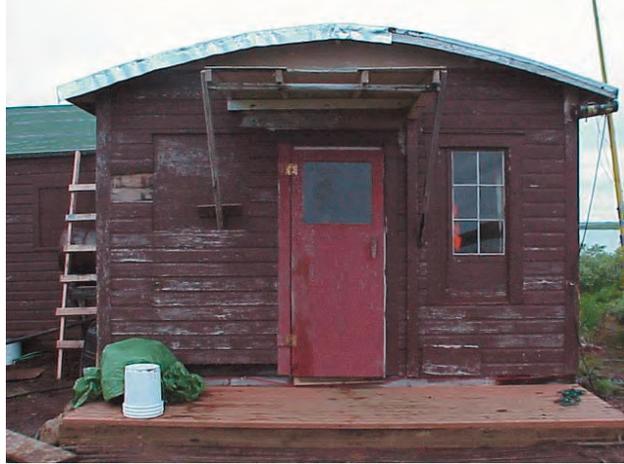
A fuel oil leak occurred at this site for an unknown amount of time. The leaking fuel system was removed on July 24, 2000. The cabin is the property of the State, and the land is managed by the Refuge. Refuge personnel have also used the cabin as a field station on occasion. Refuge personnel have dug under the cabin and confirmed the leak has contaminated the ground beneath the cabin. The fuel leak appears to be quite extensive and, it is recommended that the contaminated area be evaluated and remediated if necessary. This cabin is located on the Egegik River, and it is possible that fuel may enter the river depending on the hydrology of the area and the extent of the spill.

Front of cabin.

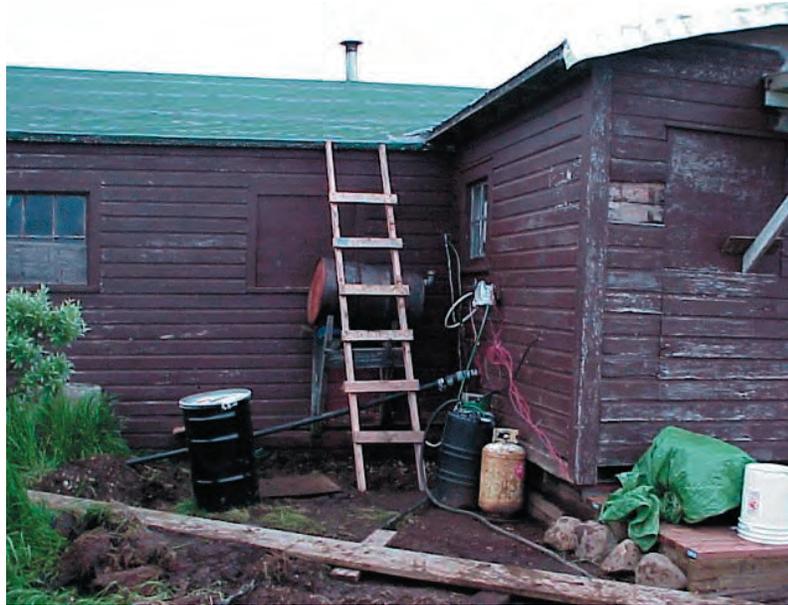
Location of leaking fuel oil.

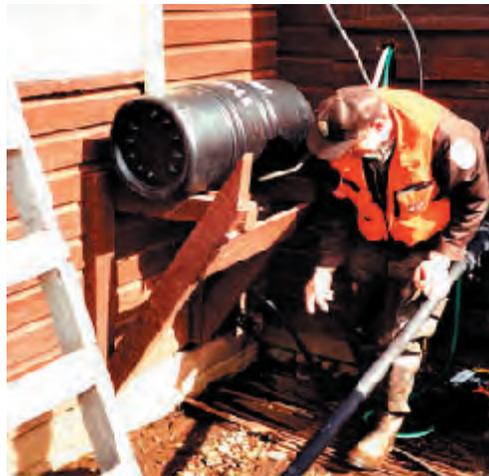
Location of leaking fuel oil (close-up).

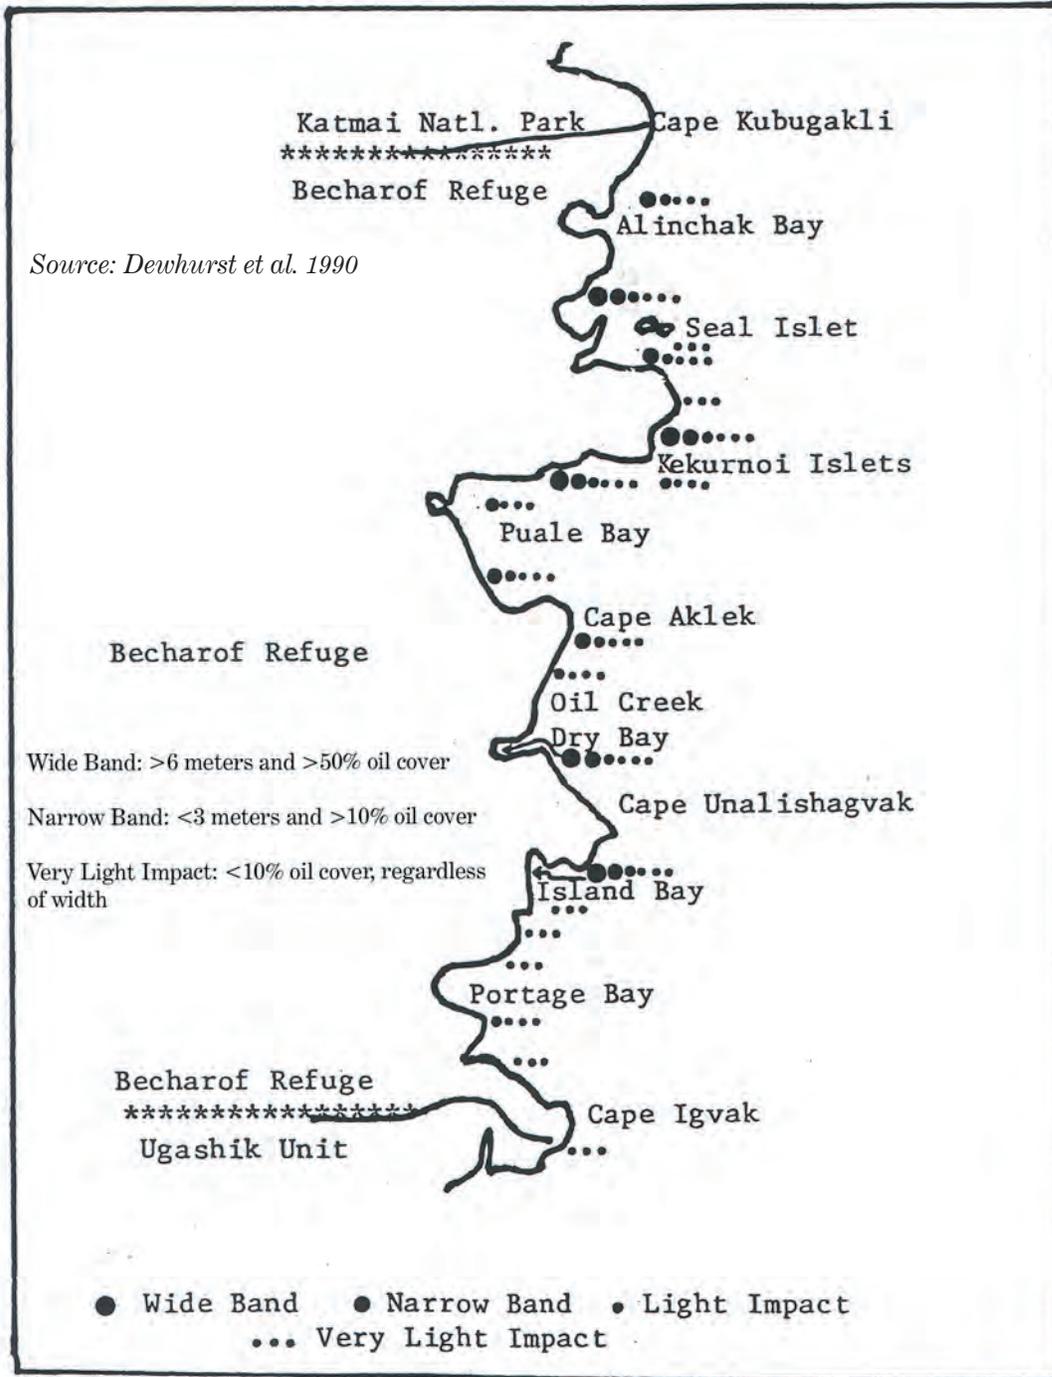
Figure 2a. Shoreline oil impacts observed on the Becharof Unit of the Alaska Peninsula/Becharof National Wildlife Refuges, Pacific Coast, April-August 1990.

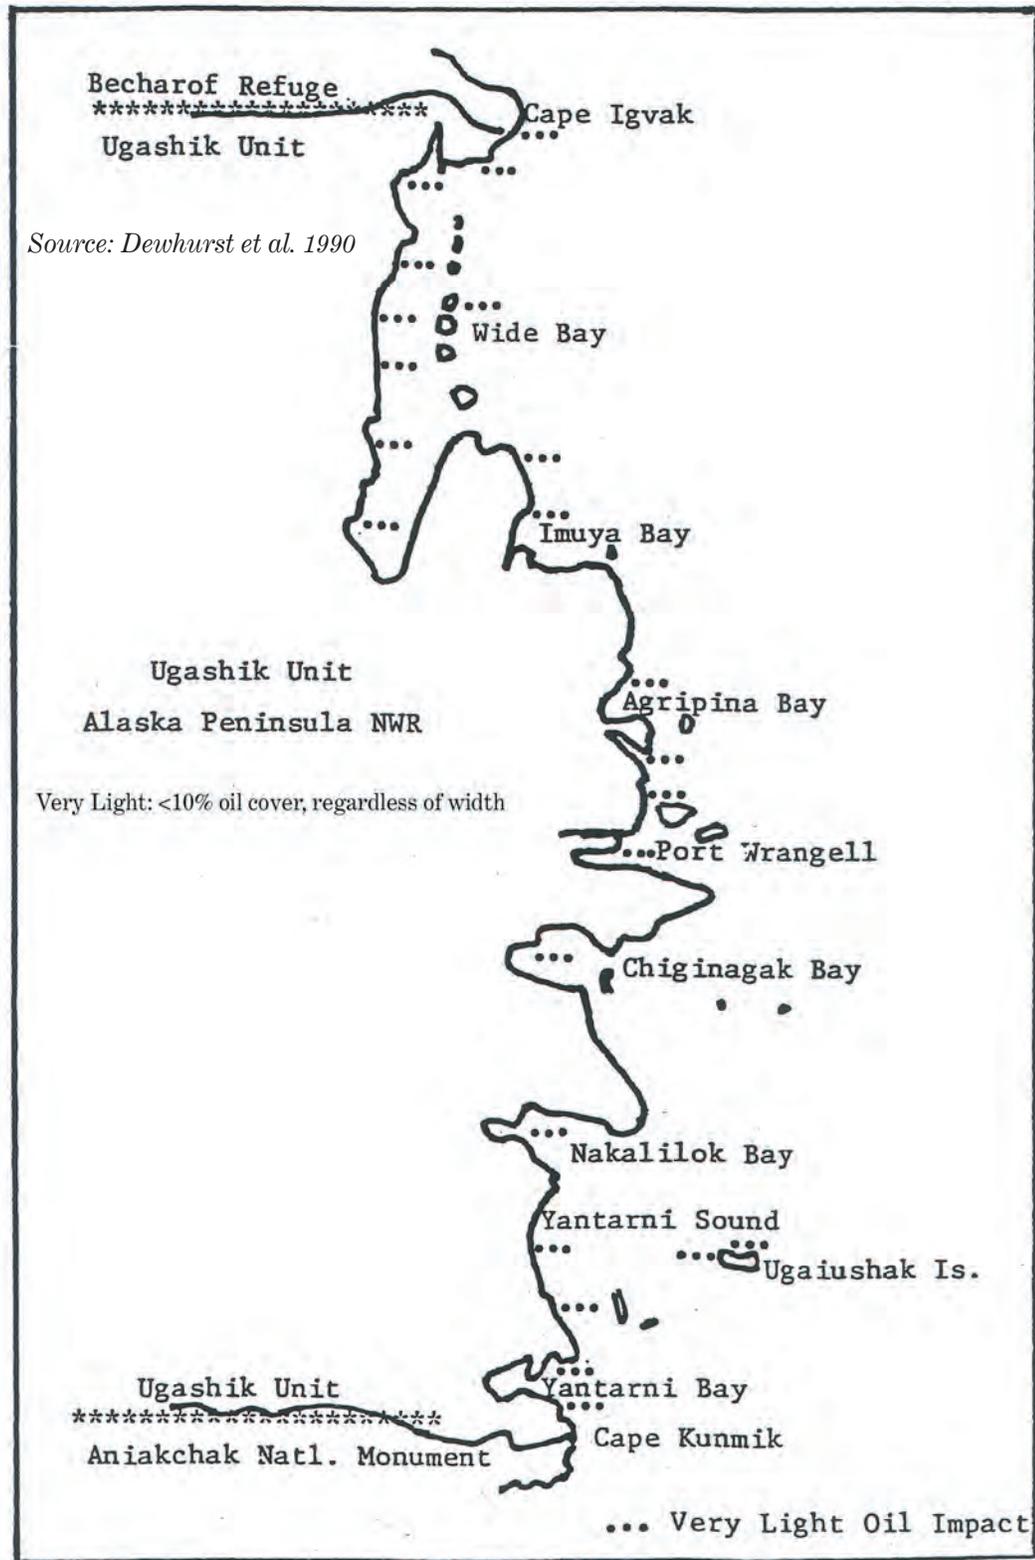
Figure 2b. Shoreline oil impacts observed on the Ugashik Unit of the Alaska Peninsula/Becharof National Wildlife Refuges, Pacific Coast, April-August 1990.

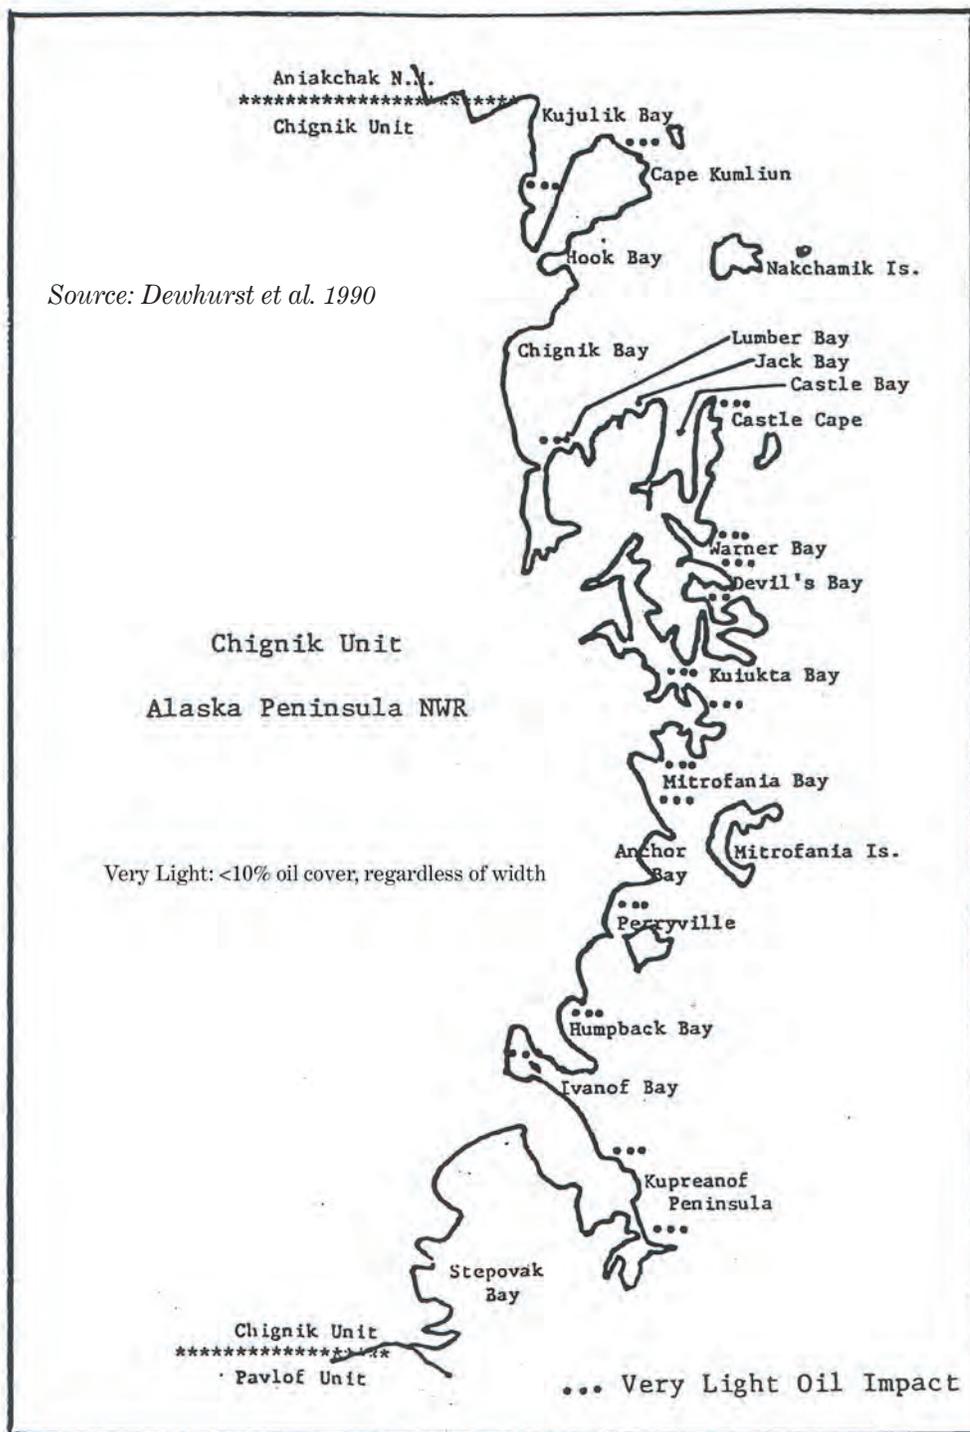
Figure 2c. Shoreline oil impacts observed on the Chignik Unit of the Alaska Peninsula/ Becharof National Wildlife Refuges, Pacific Coast, April-August 1990.
