# Izembek National Wildlife Refuge Complex

*Contaminant Assessment*

November 2004

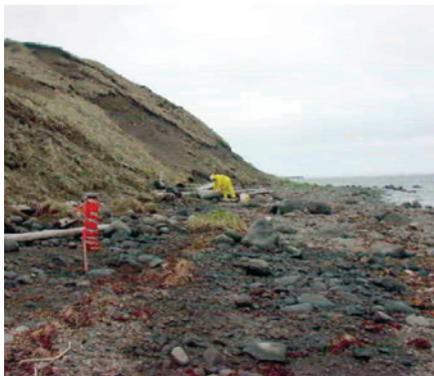
Soil stained from petroleum products is clearly visible in 2003 at the beach seeps. USACE photo.

A bioventing system was installed in 1997 to increase soil-oxygen concentrations and bolster heterotrophic bacterial degradation of diesel fuel in the soils at the Beach Seep Area (3). Initial plans for the system to run for 18 months were extended due to low numbers of bacteria. Nutrients were added in 1999 to aid soil microbes in the breakdown of DRO. Despite the added nutrients, data indicated that the system was not achieving the project cleanup goals. In 2000, the bioventing system was removed and 2,014 cubic yards of

In 1998, a high vacuum extraction (HVE) system was installed to reduce the discharge of free petroleum product to the beach. By 2004, approximately 6,200 gallons of diesel fuel contamination was removed from the soil. Although no remaining sources of contamination have been discovered at these sites, free product continues to cause surface staining and sediment contamination along the coast which may introduce contaminants to trust resources.

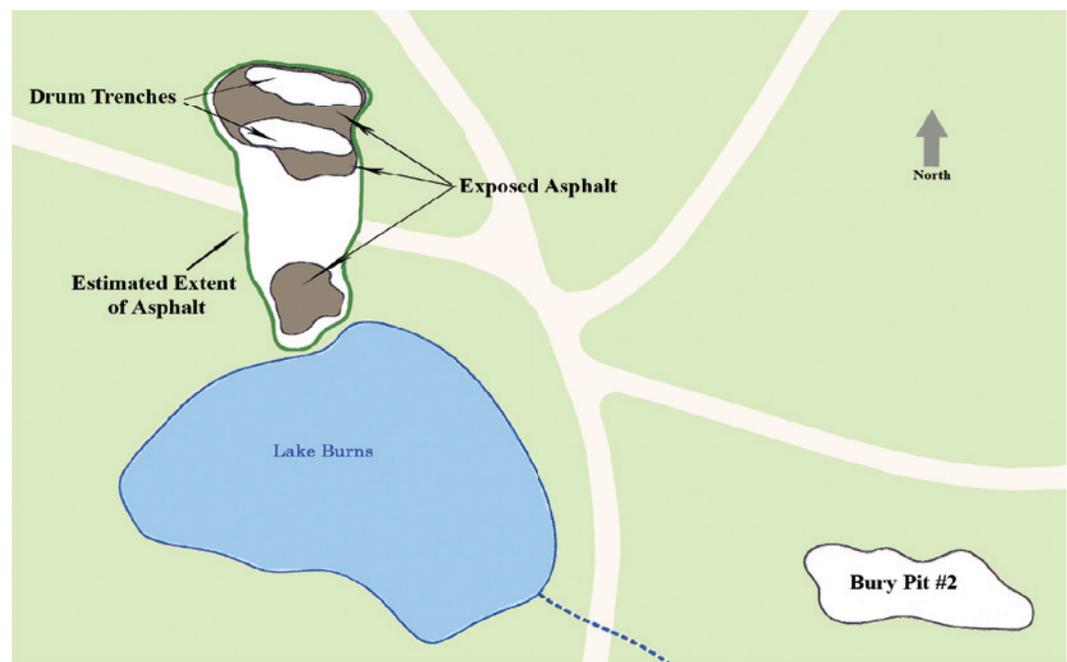
**Figure 5. General location of asphalt seeps on state land adjacent to Refuge.** Adapted from USACE.

trenches associated with the seeps that require remedial action (Figure 5). A geophysical survey conducted in 1999 indicated that each trench was approximately 125-feet by 25-feet and contained an estimated 2,800 drums to a depth of 15-feet. Test pits dug at the northern drum trench indicate that some of the drums contain petroleum compounds and that surrounding soils are above risk-based soil cleanup standards. During the 2002 remedial investigation, an additional burial pit that had been a permitted landfill during cleanup efforts in the 1980s was detected. This pit (referred to as Bury Pit No. 2) is approximately 230-feet long by 90-feet wide to a depth of 15-feet and likely contains other debris in addition to buried drums.

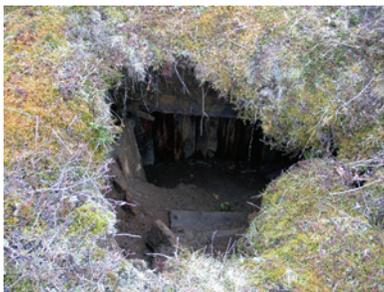
Hole revealing a wooden trench near the asphalt seeps. D. Rocque/USFWS.

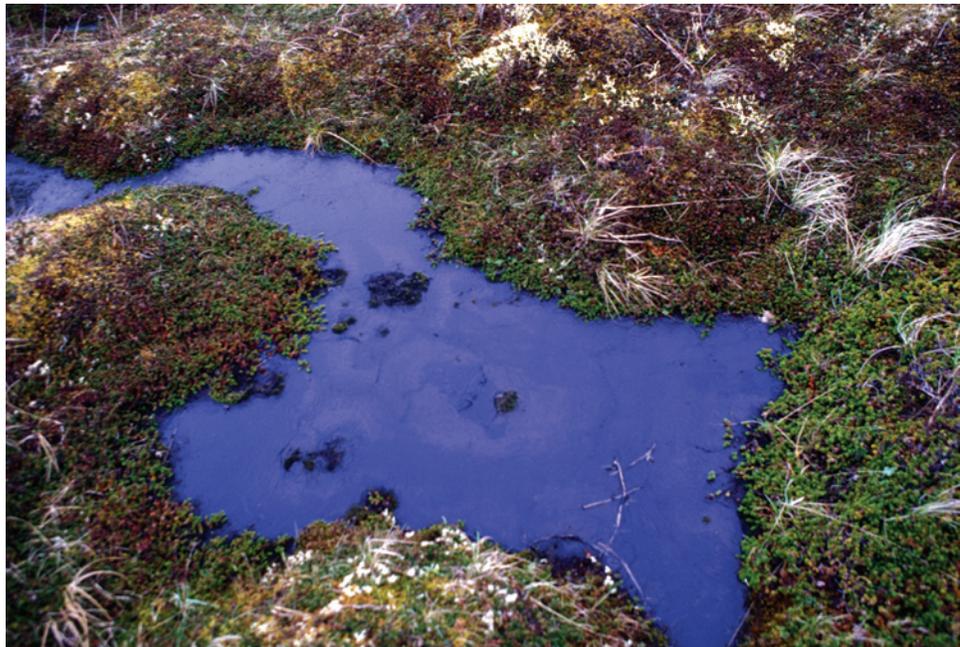
A close-up of one pool of asphalt as it appeared in Spring 2004. D. Rocque/USFWS.

Although new areas of asphalt become exposed each year and wildlife has become entrapped in exposed asphalt, the USACE claims that the seeps are immobile, and therefore do not pose a risk to human health or the environment. The current USACE preferred action for the Asphalt Seeps site is to place a permeable soil cap over the seeps, rather than remove the material, thereby causing less impact to the tundra than would result from asphalt removal (5). Remedial actions will also include removal of drums from the two drum trenches. Rather than excavate Bury Pit No. 2, monitoring wells would be installed around the pit to monitor

groundwater quality. It has been assumed that drums in this pit were empty when buried and therefore do not pose a hazard that warrants excavating the debris and impacting the surrounding tundra. Comments on the proposed plan were addressed and the Decision Document should be completed by the end of 2004.

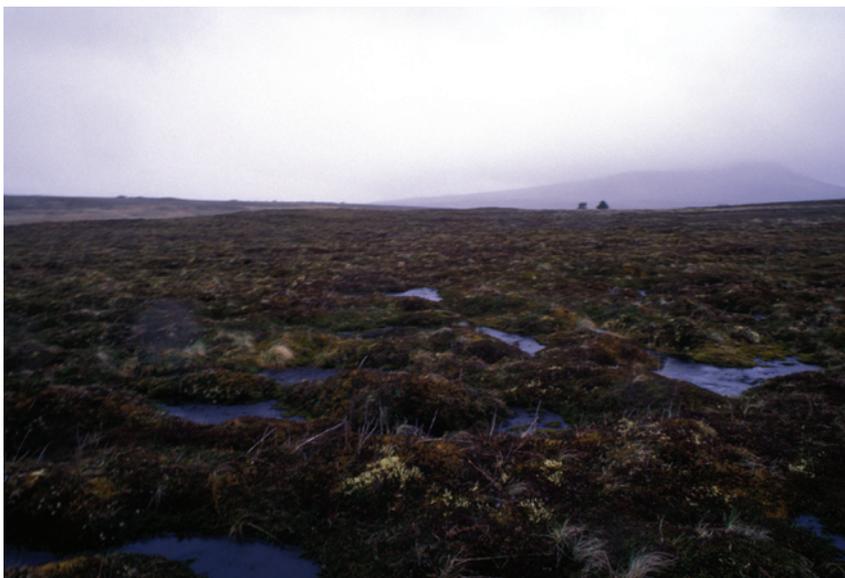
Several pools of asphalt in the southernmost area of exposed asphalt. D. Rocque/USFWS.

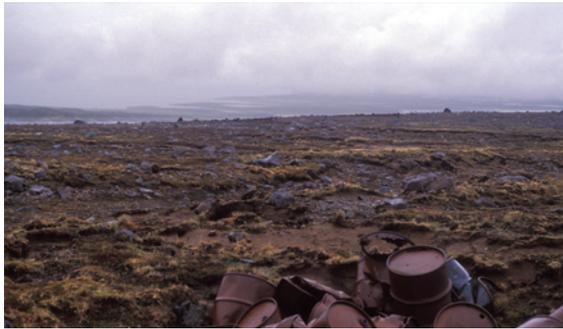
Empty drums rusting in a pile on Mount Baldy. D. Rocque/USFWS.

The areas with the most debris were located on Mount Baldy and Frosty Peak. The Mount Baldy site consisted of several collapsed buildings and a drum pile. The Frosty Peak site had a wooden cistern, an old World War II shower facility that is still standing, and a collapsed building. Interestingly, the radar dish that was present at the Frosty Peak site the previous year was not located in 2004. It is unknown whether the dish was removed by contractors or succumbed to strong winds and/or avalanches that occur regularly in the area. Service personnel saw no soil staining or other evidence that indicated POL contamination at these sites. However, both areas are in designated Wilderness Areas and the occurrence of solid debris is incompatible with this designation. Responsible Parties and the Refuge Complex may want to investigate compatible (non-mechanized) ways to remove debris in Wilderness Areas.

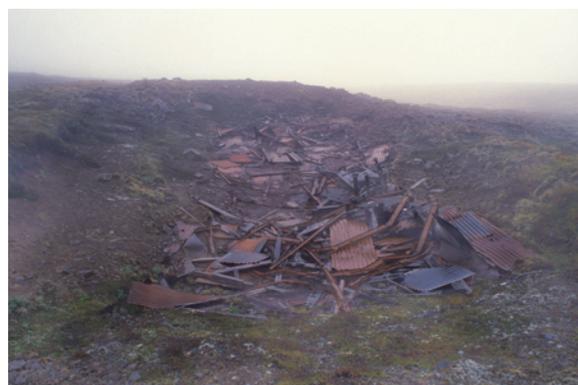
A collapsed World War II building on Mount Baldy. D. Rocque/USFWS.

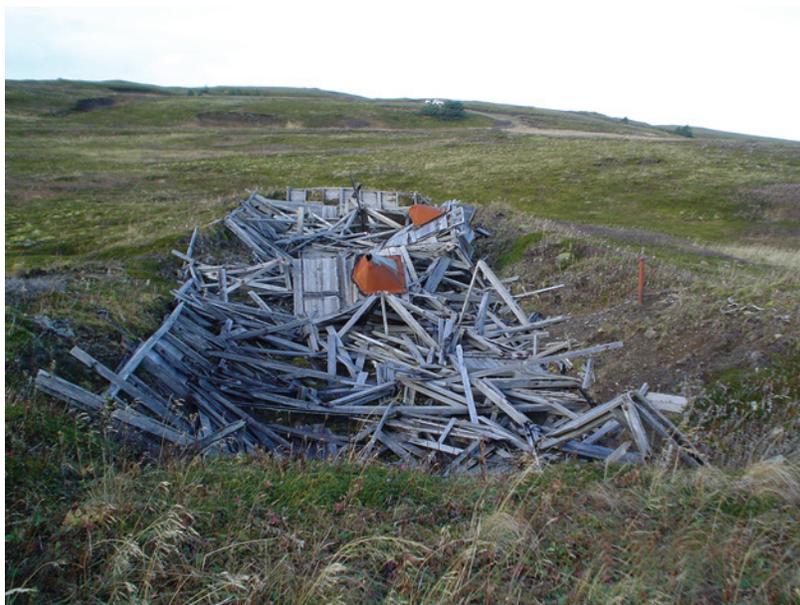
Another area with World War II debris is located at mile 2.5 on the road to Grant Point. The remains of three buildings are within Refuge boundaries on the northeast side of the road. This site consists of wooden and rusted metal. Service personnel saw no signs of POL or other contamination at this site.

One of three collapsed World War II buildings on the Grant Point Road. R. Poetter/USFWS.

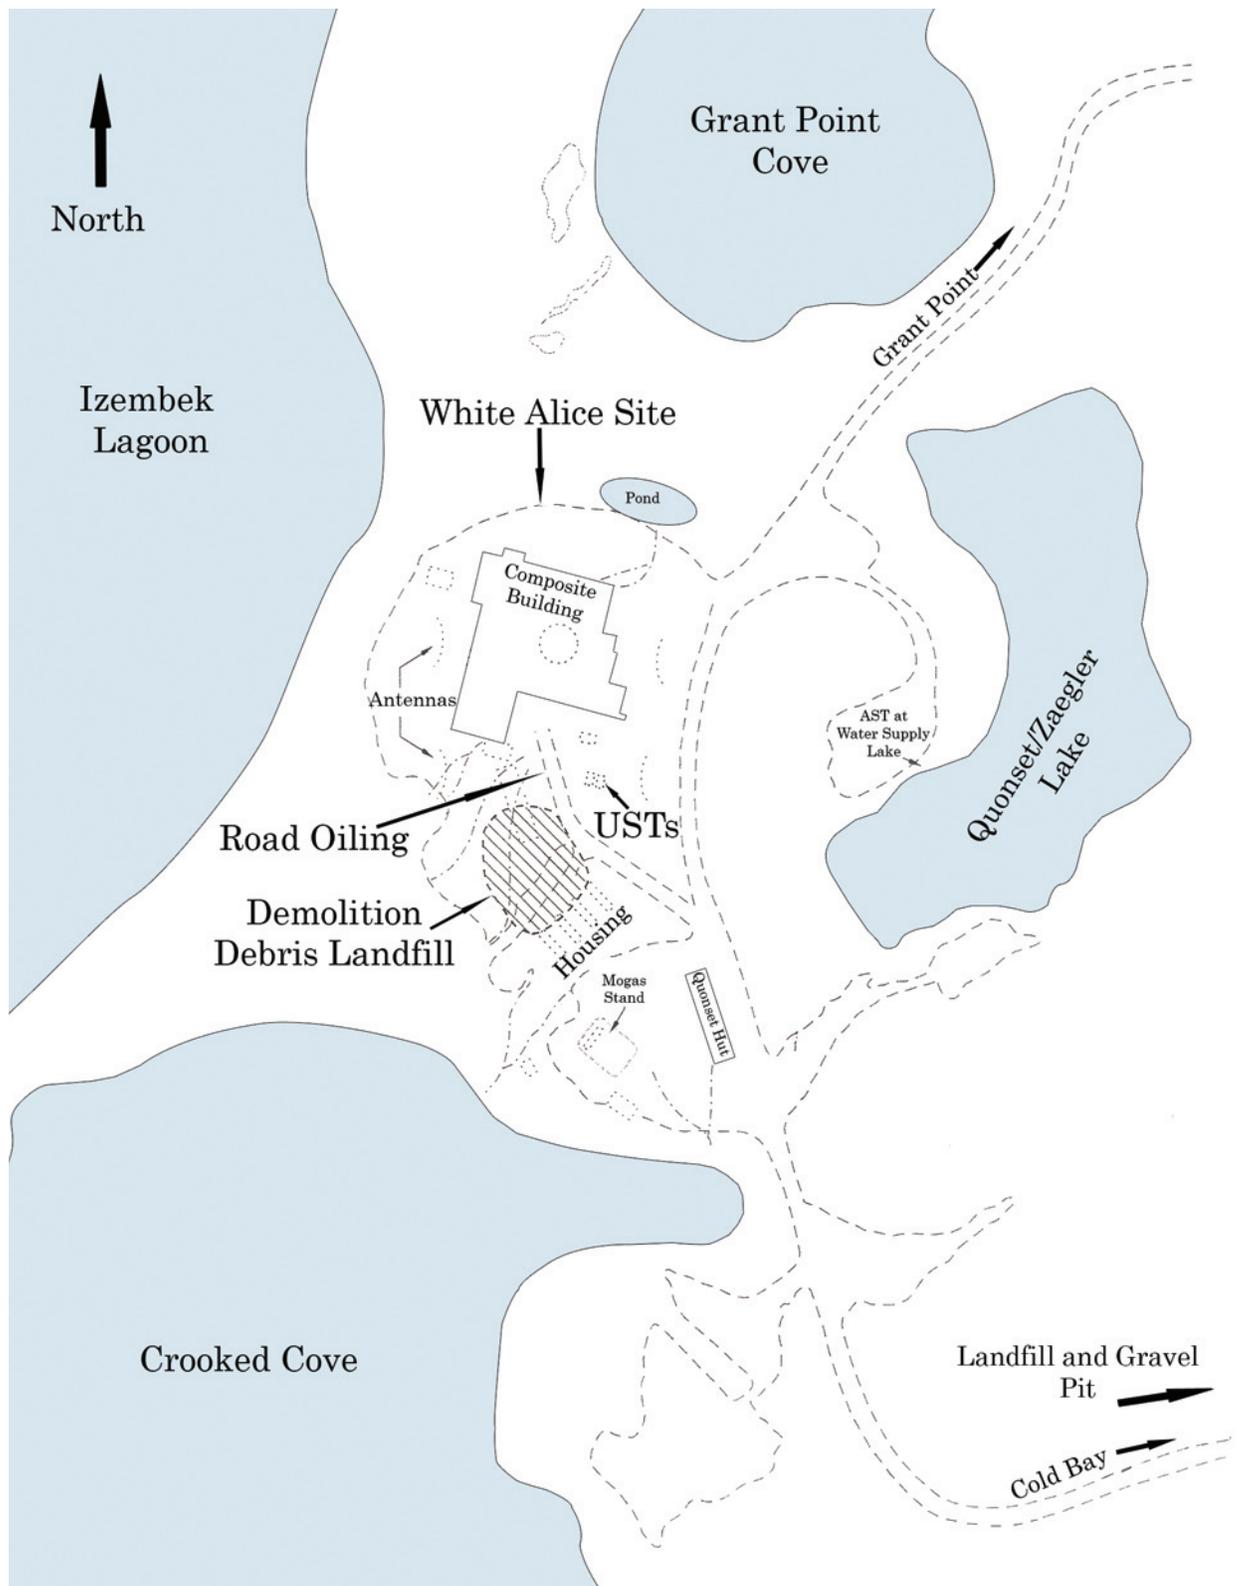
Figure 6. Site map for White Alice Communication Station. Adapted from (3).

Under the Air Force’s Installation Restoration Program (IRP), cleanup was initiated in the early 1980s by conducting an initial comprehensive record search to document activities at the Cold Bay AFS. Two areas of potential contamination were identified as a result of the records search and consultants to the USAF recommended that the landfill and the spill/leak area undergo field sampling and contaminant analyses. A preliminary assessment by the USACE identified other potential contaminated sites, including the WACS site, road oiling areas, and the landfill/gravel pit (Figure 6). These sites are addressed separately.

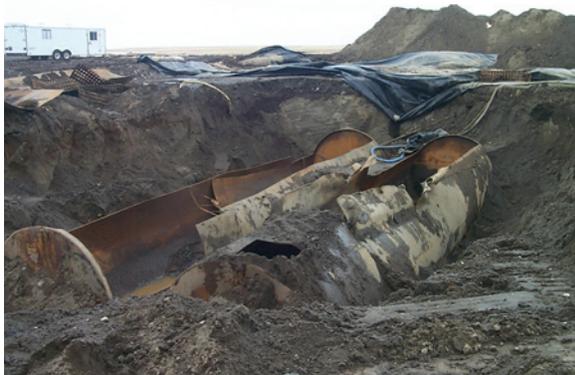
Two USTs that were removed in 2001. R. Poetter/USFWS.

In 2001, USAF proposed and carried out the removal of the USTs, excavated diesel contaminated soil around the tanks to a depth of 15 ft, and remediated the soils through thermal desorption (remediation goal of 1,000 ppm DRO). Groundwater monitoring wells were installed around the landfill to determine whether contaminants were migrating offsite. Natural attenuation was used to achieve concentrations of less than 1.5 ppm of DRO in groundwater. Physical hazards were eliminated by filling sinkholes, adding additional cover material over the demolition debris landfill (2-3 feet cover), and grading and re-vegetating the area. Analytical results from soil samples collected from the WACS site met the cleanup standard and no further soil treatment was required.

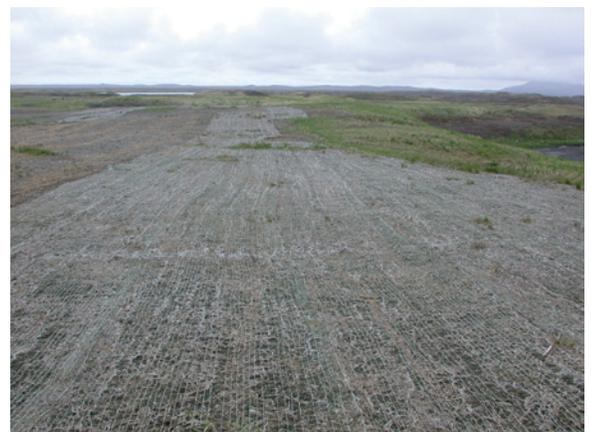
Nylon net used to keep soil and seeds in place was blown away in places in spring 2004. D. Rocque/USFWS.

- Cold Bay Air Force Station: Capped and graded areas need to be re-vegetated to avoid erosion of soils. Seed mats used to re-vegetate and control erosion have blown free and pose a hazard to wildlife. Caps to the landfill and other areas require annual inspection and continued monitoring of ground water via monitoring wells is required. It is also recommended that periodic soil samples be collected and

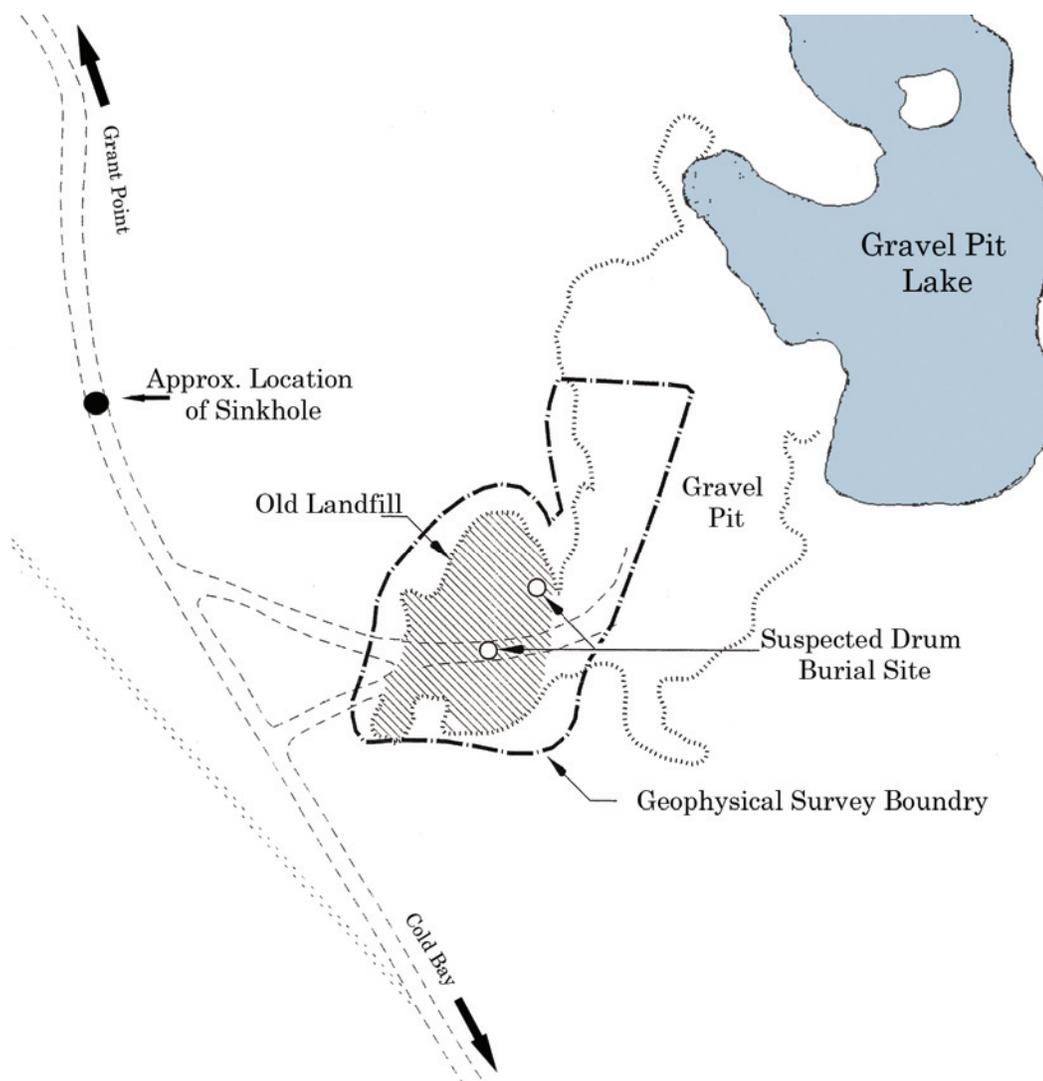
Figure 7. Site map for landfill/gravel pit and sinkhole. Adapted from (3).

The USAF landfill is located about six miles outside of Cold Bay on Complex Land and sits at an elevation higher than the immediate surroundings (Figure 7). The landfill was operated from 1971 – 1976 under a special use permit from the Service. According to the USAF, the landfill primarily received domestic waste. It is unknown what, if any, hazardous wastes from Cold Bay AFS were deposited in the landfill. Records indicate that hazardous wastes generated from Cold Bay AFS included contaminated fuel (200 gal/yr), petroleum based fluids from power generators and vehicle maintenance (1,900 gal/yr), small quantities of ethylene glycol (22 gal/yr), battery acid (3 gal/yr), and paint thinners (2 gal/yr). These waste liquids were either shipped off base, used in fire training exercises, road dust control (until the late 1970s), or deposited in the landfill (7).

In 2001, during gravel hauling for remediation of the WACS site, a sinkhole developed at milepost 7.5 (Figure 7). The hole was two feet wide, with a depth of about two feet. The sinkhole contained water with a sheen of oil (13). When the oil sheen was removed with absorbent pads, swishing in the hole caused the appearance of oil again. A metal object could be felt at the bottom of the hole, indicating the road had been built on crushed barrel(s) to provide a solid bottom over the marsh. Nine test pits were excavated to determine the extent of contamination. Soil and liquid samples were taken for analyses from each pit, all of which contained standing water. Floating petroleum product was visible in tests pits located five feet north and south from the sinkhole and very small amounts of petroleum were visible at test pits located 10 feet north and south from the original hole. Test pits located 15 feet in all directions from the sink hole contained no visible oil sheen on the water surface. Analytical results indicated that samples containing petroleum were #4 fuel oil. Wetlands on either side of the road showed no impact and based on results of the pit excavation, it is estimated that 49 gallons of product were floating on top of a perched water table about two feet below ground surface. Test pits and the sinkhole were filled with gravel. Remedial recommendations included removal of the product and impacted soils, but no removal actions have been performed to date.

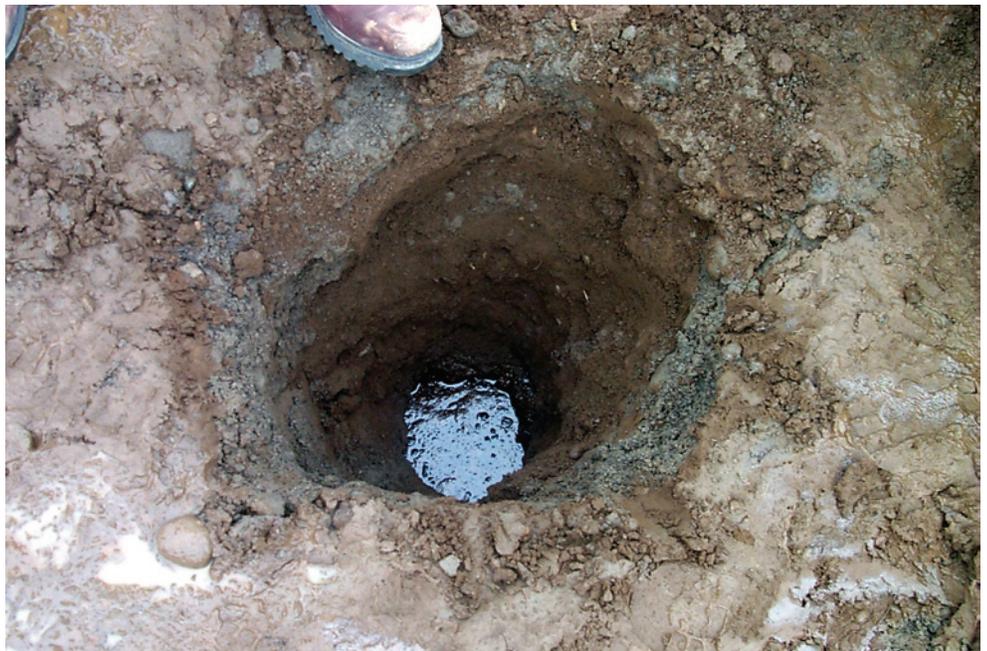
Oil sheen in a sinkhole that developed during gravel hauling in 2001. R. Poetter/USFWS.

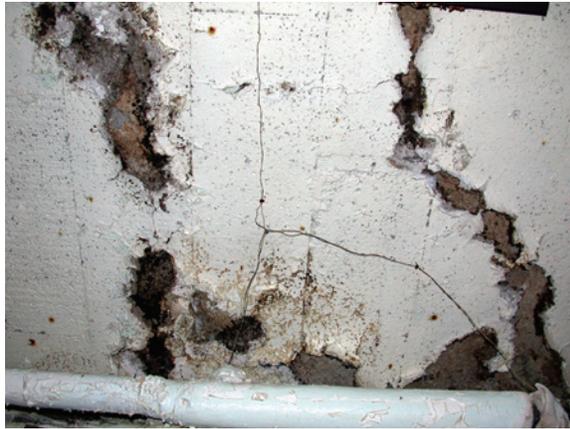
Ceiling tile and pipe insulation that likely contains asbestos. D. Rocque/USFWS.

and areas with high percentage of asbestos were found in the boiler room and pipe insulation. Surface soil samples indicated that several areas were contaminated with petroleum products, however PCBs and solvents were not detected in any sample. Surface soil samples analyzed for trace elements were not elevated above background concentrations. Highest concentrations of TPH were detected in surface soil samples from the north side of the LORAN building, which had concentrations as high as 460,000 ppm (1,600 – 460,000 ppm). While ADEC does not regulate based on TPH, the maximum allowable concentration for RRO (the least toxic petroleum hydrocarbon) is 22,000 ppm. Sub-surface samples collected next to storage tanks had elevated levels of TPH, up to 4,200 ppm. A soil sample from the wood garage had a TPH concentration of 7,300 ppm. Liquid samples collected from inside underground storage tanks contained leaded gasoline and samples collected from 55-gallons drums contained lubricating oil.

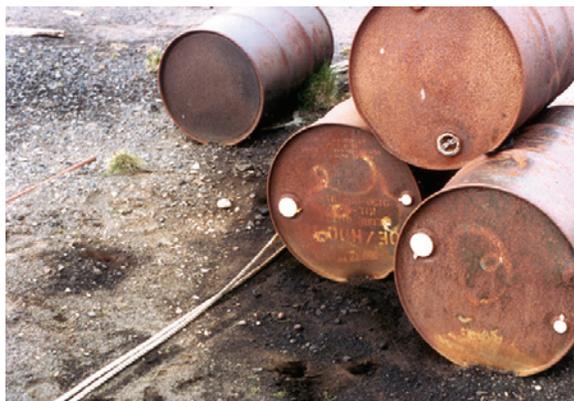
Leaking lube oil drum left at the LORAN station after it was closed. USFWS.

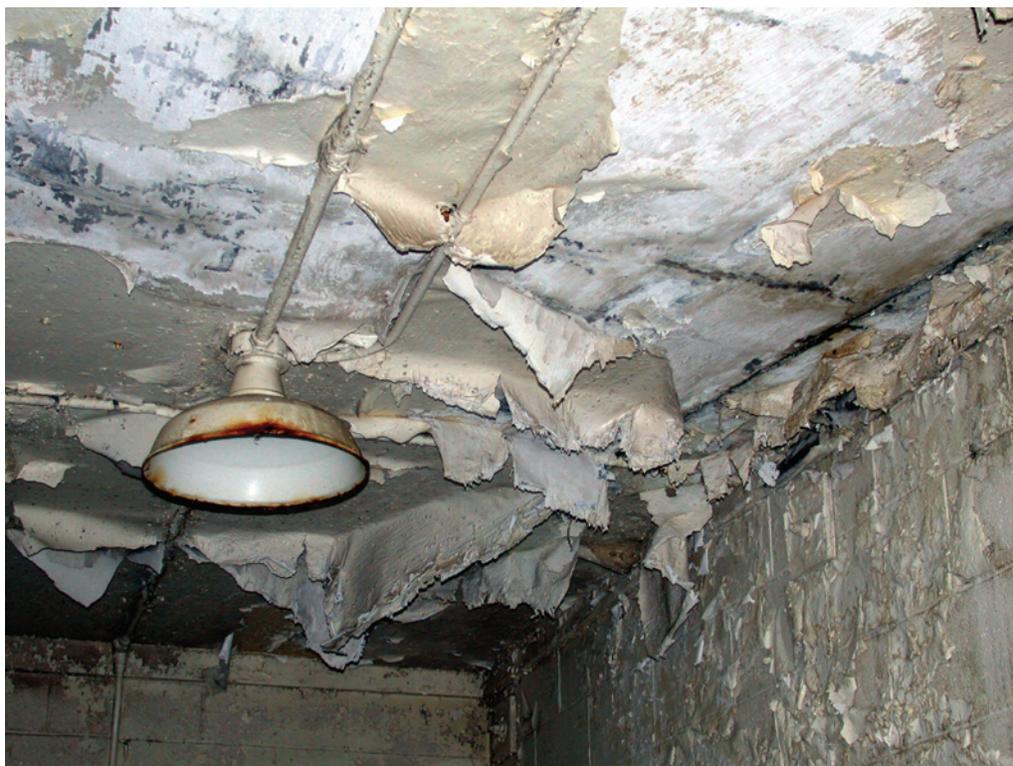
Peeling ceiling and wall paint at the LORAN station. D. Rocque/USFWS.

During the site visit in 2004, Service personnel found the LORAN station in a general state of decay. The majority of the windows were broken and ceiling tiles were decaying and falling down. Large areas of paint were peeling off the walls and ceiling. Debris, including foodstuffs, oil filters, and furniture was scattered throughout the building and rusted and empty 55-gallon drums were stored in a generator room. Overpacks of 55-gallon drums and assorted smaller containers were stored in the former garage and outside the building and were not protected from the weather. The lighthouse was empty and not in as poor condition as the LORAN station, but years of abandonment was evident. Abandoned vehicles and metal and wooden debris were scattered outside the buildings. At present, no plans to remove the buildings and restore the site are underway.

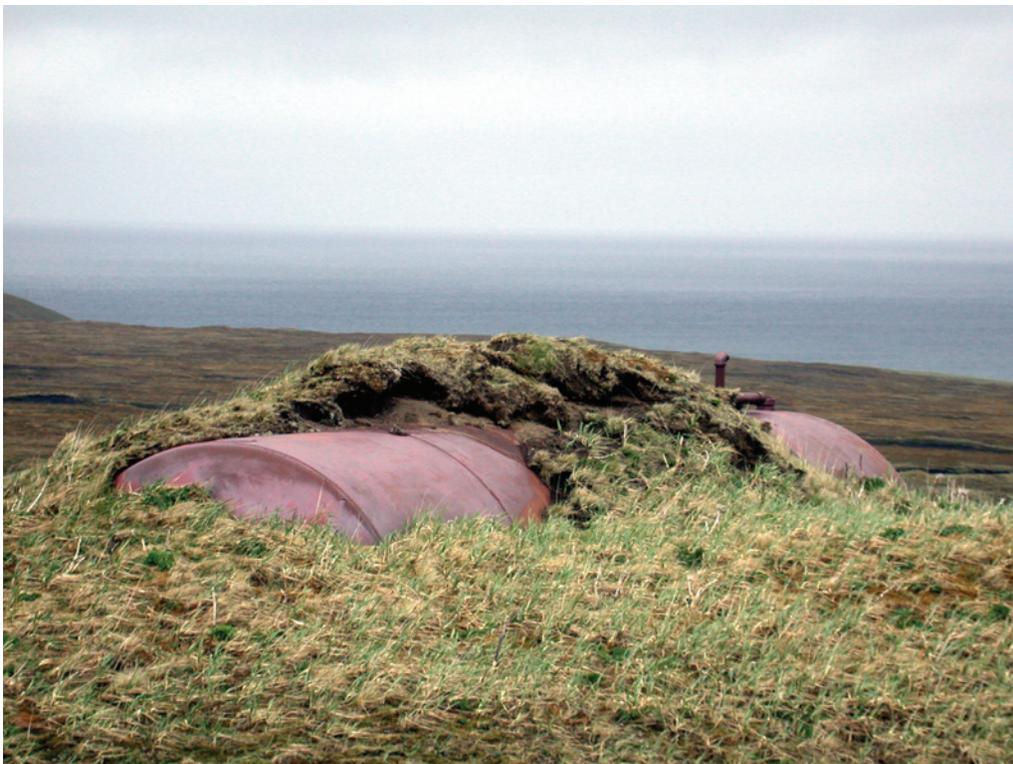
An underground storage tank at the WACS that has become exposed. D. Rocque/USFWS.

- Unimak Island: Removal of fuel from storage tanks and drums. There is an estimated 18,500 gallons of fuel in ASTs at the WACS site and an unknown quantity of fuel at both USCG sites (capacity at the two site exceeds 500,000 gallons of fuel storage in ASTs and USTs). The potential of a leak from a UST or a spill from an AST is high. According to a 1998 document “[t]he most significant environmental concerns at Cape Sarichef and Scotch Cap include the presence of USTs, ASTs, and 55-gallon drums that contain product waste” (15). At a minimum, all fuel should be removed from the three sites as an interim removal action.

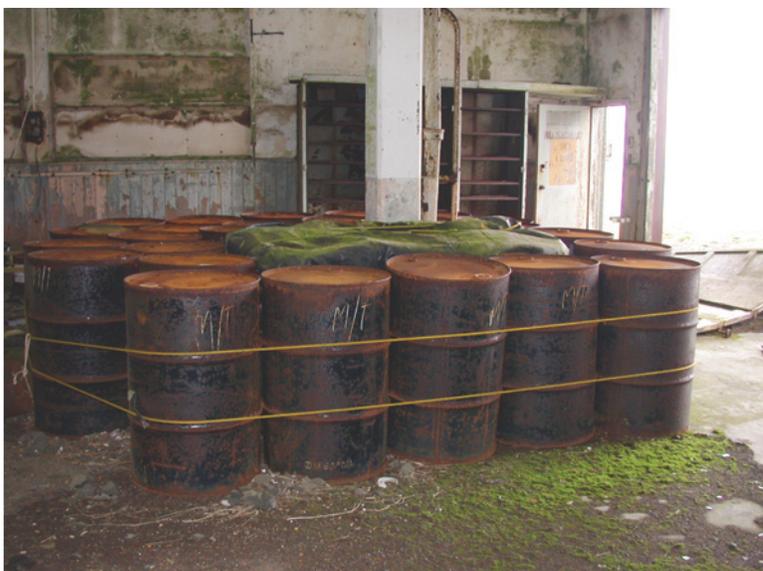
Six 55-gallon drums containing liquid surrounded by empty drums in the WACS garage in 2004. D. Rocque/USFWS.

Service personnel found buildings intact and in fair condition during a site visit in 2004. The 55-gallon drums of liquid that were generated during the 1999 fuel transfer were still in place inside the

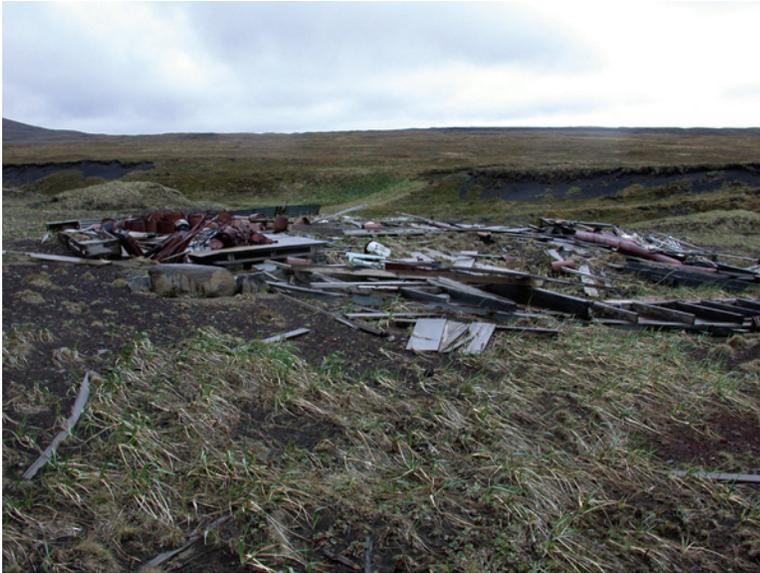
A debris pile containing empty drums, canisters, and wood located near the WACS site. D. Rocque/USFWS.

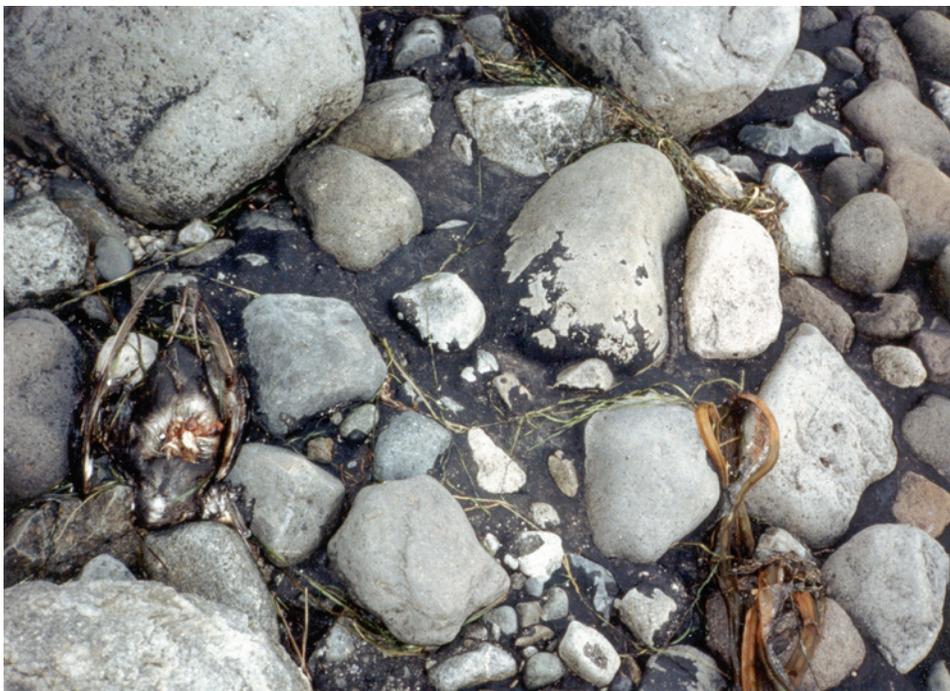
“Tar balls” and a dead shearwater on the beach at Kinzarof Lagoon in 1989. M. Chase/USFWS.

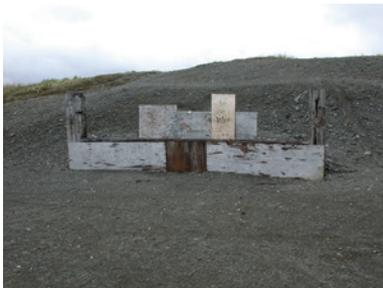
The wooden backdrop that forms the shooting range at the Refuge. D. Rocque/USFWS.

A small shooting range exists on Izembek National Wildlife Refuge and is used for training and by hunters sighting in rifles. The range is a former military shooting range that had multiple berms, but only the biggest berm is currently used. A small pond is located downhill from the shooting range. Given the environmental characteristics of the area, it is unlikely that this shooting range poses a significant risk to wildlife. However, lead shot from this range has the potential to leach into soils and ground or surface waters. It is recommended that a seasonal cleanup be performed at this site to minimize the accumulation of lead at this site.
