Alaska Fish-Friendly Culverts Hold Tight Through 100 year flood

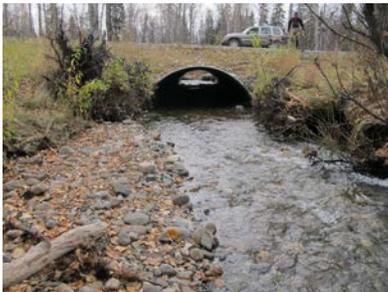
Post-flood: the Mat-Su Borough and USFWS upgraded a 5 foot round culvert on Colter Creek with this fish-friendly 14 foot arch following 2006 floods. Fish-friendly culverts have water depths, velocities, and channel characteristics that mimic the natural stream. K.Mueller / USFWS

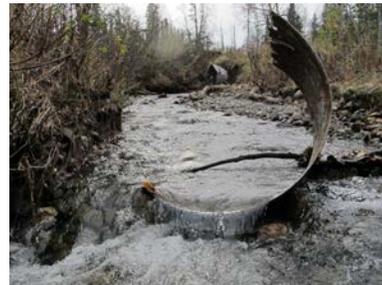
Post-flood: an undersized culvert on Nurses Creek sustained damage both its inlet and outlet, and caused flood waters to overtop the road. K.Mueller / USFWS

Approximately sixty-five percent of inventoried culverts in the Mat-Su Valley still present partial or total barriers for fish seeking upstream and/or downstream passage. Replacement with fish-friendly culverts will help keep fish habitat and communities connected, no matter what the weather!
